Assessment of Strike of Adult Killer Whales by an OpenHydro Tidal Turbine Blade

Final Report

January 2014

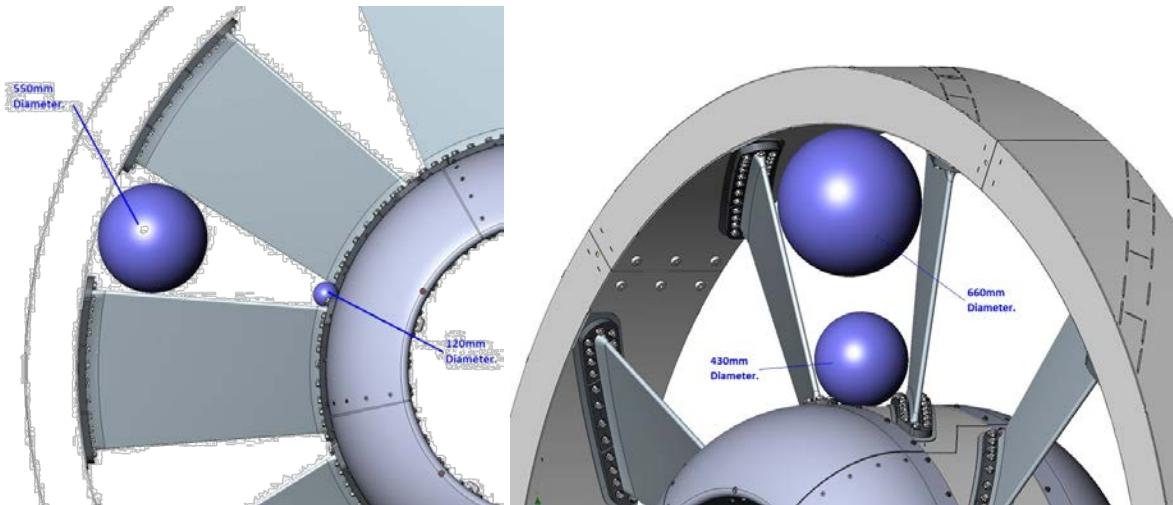
Figure 2. Front and isometric view of OpenHydro schematic with spacing dimensions of blade edges.

PNNL and SNL scientists and engineers developed a scenario designed to estimate the most risky conditions under which a strike could occur (turbine blade strike on the head of an adult whale at the highest tidal flows and, consequently, the highest turbine blade rotation speeds). SNL carried out blade impact modeling, using turbine specifications provided directly by OpenHydro, to determine the force with which a blade might strike the animal (Figure 2). PNNL examined available data on the biomechanical properties of the SRKW tissues derived from SRKW tissue testing and surrogate materials including synthetic rubber, natural rubber, other composite materials, and human skin.

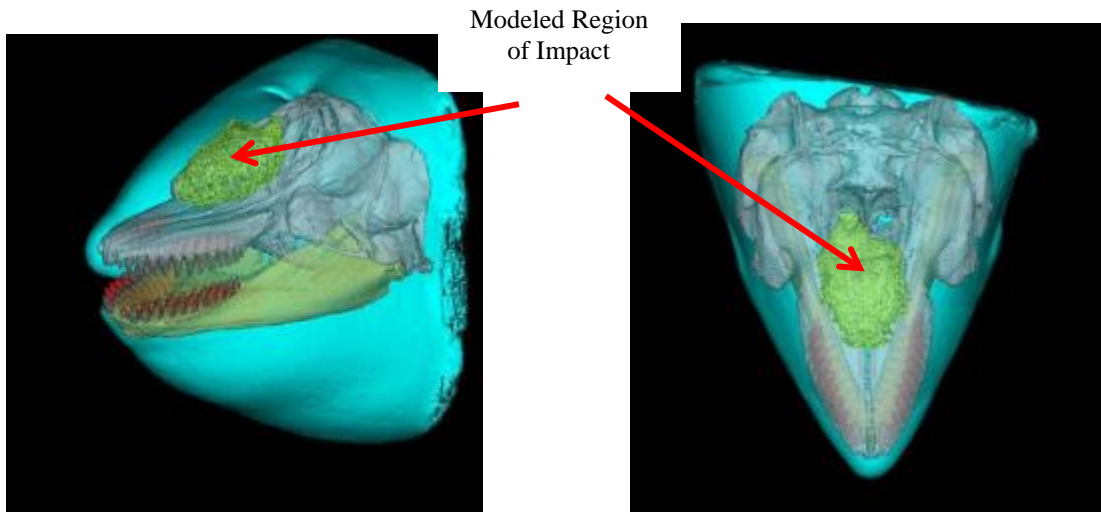
Figure 3. CT scan-based images of the head of an adult female SRKW from the side (left) and from top view (right). The teeth are shown in red, bone in light color, and the various soft tissues in other colors. The region of impact used for modeling purposes is indicated.

PNNL obtained data for whale head morphology and anatomy from CT scans of the head of an adult SRKW that died in 2002 (Figure 3). Information about the biomechanical properties of whale tissues was found in the scientific literature (Appendix A).

The adult killer whale for which CT scan data were available and the adult killer whale modeled were similar enough in size so that the available morphology and anatomy data from CT scans could be used in assessment of the probable injury to an adult killer whale caused by turbine blade strike. The tissues of concern included the skin of the whale, other soft tissue, and mandibular bone. Details of the head morphology analysis can be found in Appendix A.

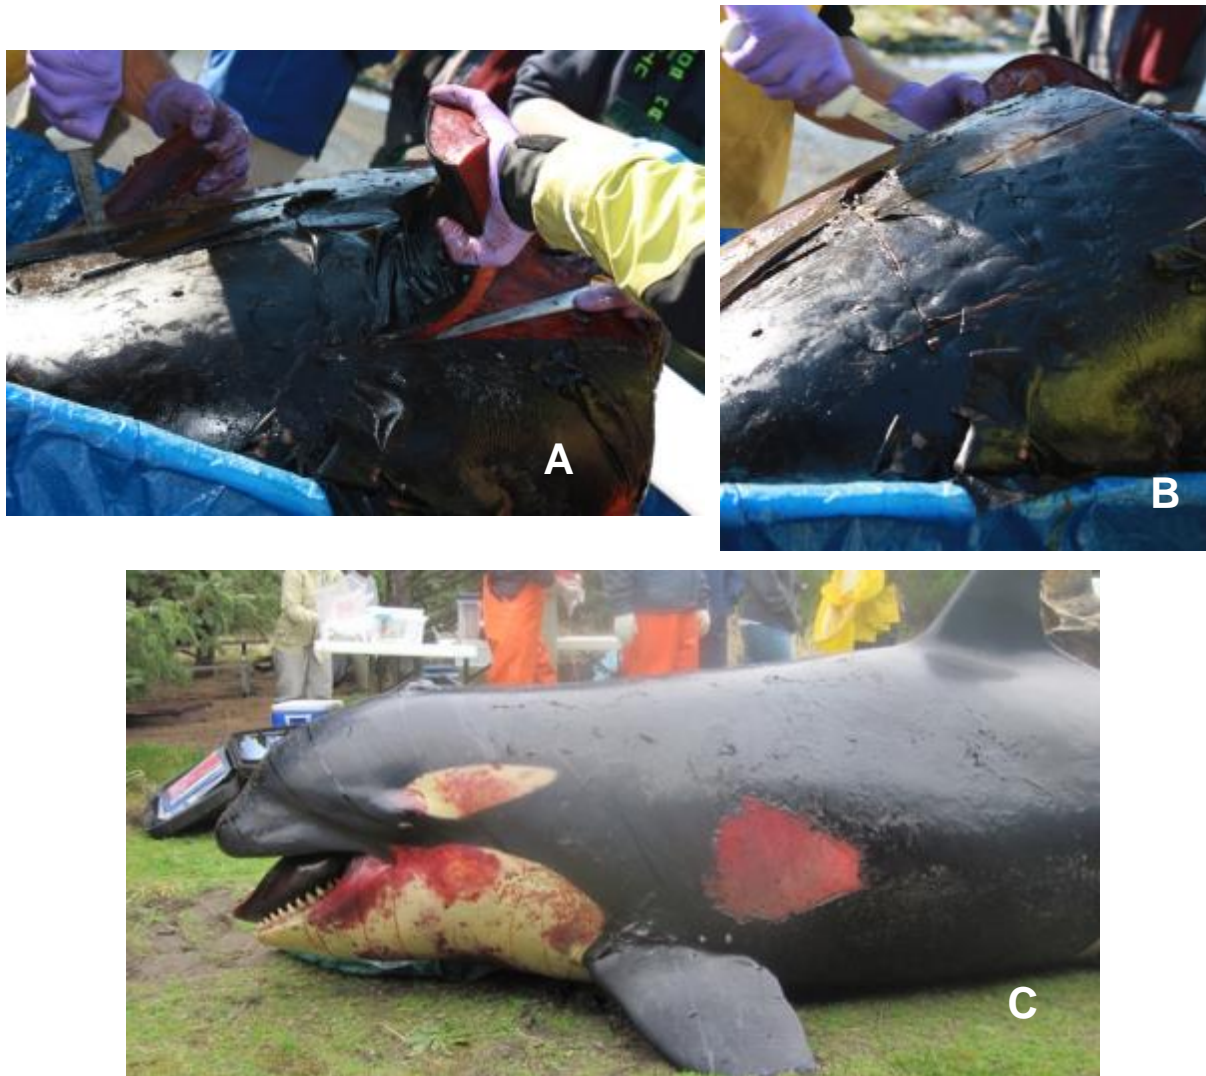
Figure 4. Photographs from necropsy of L112 on February 12, 2012. Photos A and B show the skin sample used for tissue testing, at the time of the necropsy. The tissue was frozen shortly thereafter. Photo C shows L112 prior to necropsy; the skin tissue was clearly already degraded at the time of the necropsy.

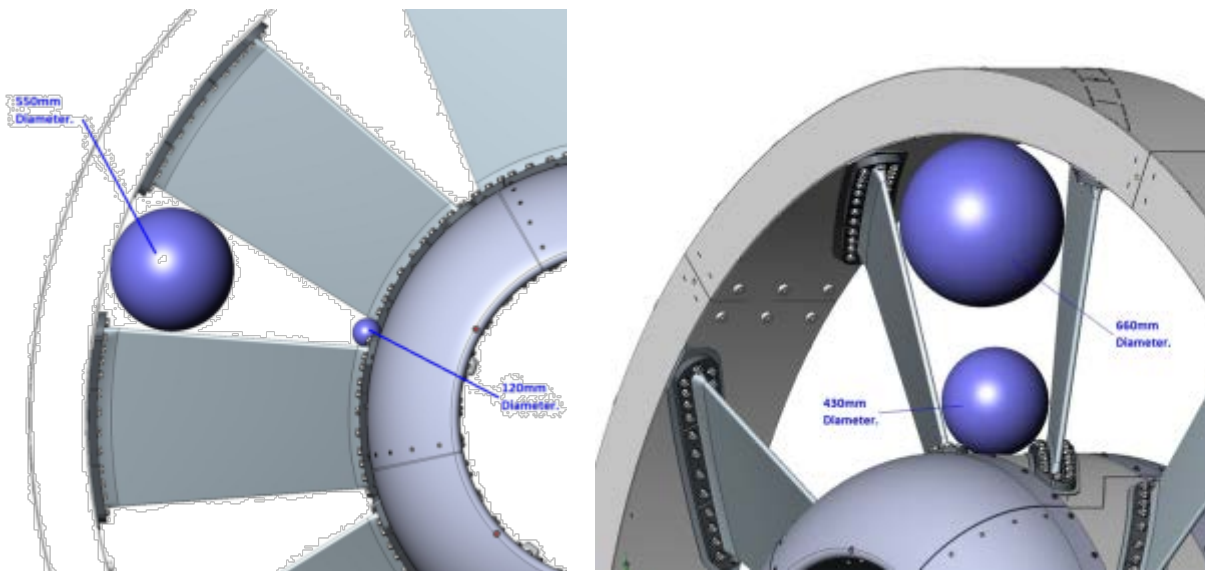
Figure 5. Left: Front view of blade with spacing dimensions of blade edges. Right: Isometric view with spacing between blade faces.

The OpenHydro tidal turbine characteristics, including the material properties, dimensions, and blade speeds, remained unchanged from FY12 (Figure 5).

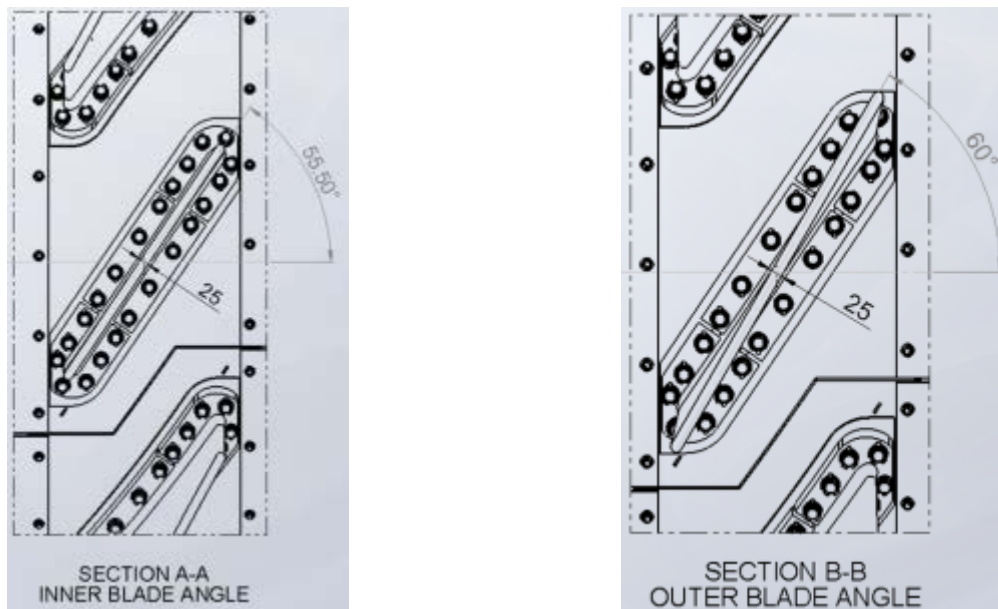
Figure 6. Left: Angles between inner blade edges. Right: Angles between outer blade edges.

The proposed device for deployment in Admiralty Inlet is an open-center OpenHydro tidal turbine with a nominal diameter of 6 m; the diameter of the rotor blades within the duct is 4.8 m. The rotor blades are about 1.25 m long with a central ducted open area with a nominal diameter of about 2.25 m. The rotor has a mass of 6200 kg. Figure 5 shows the spacing between the blade faces. Figure 6 shows the angles between the outer and inner blade edges.

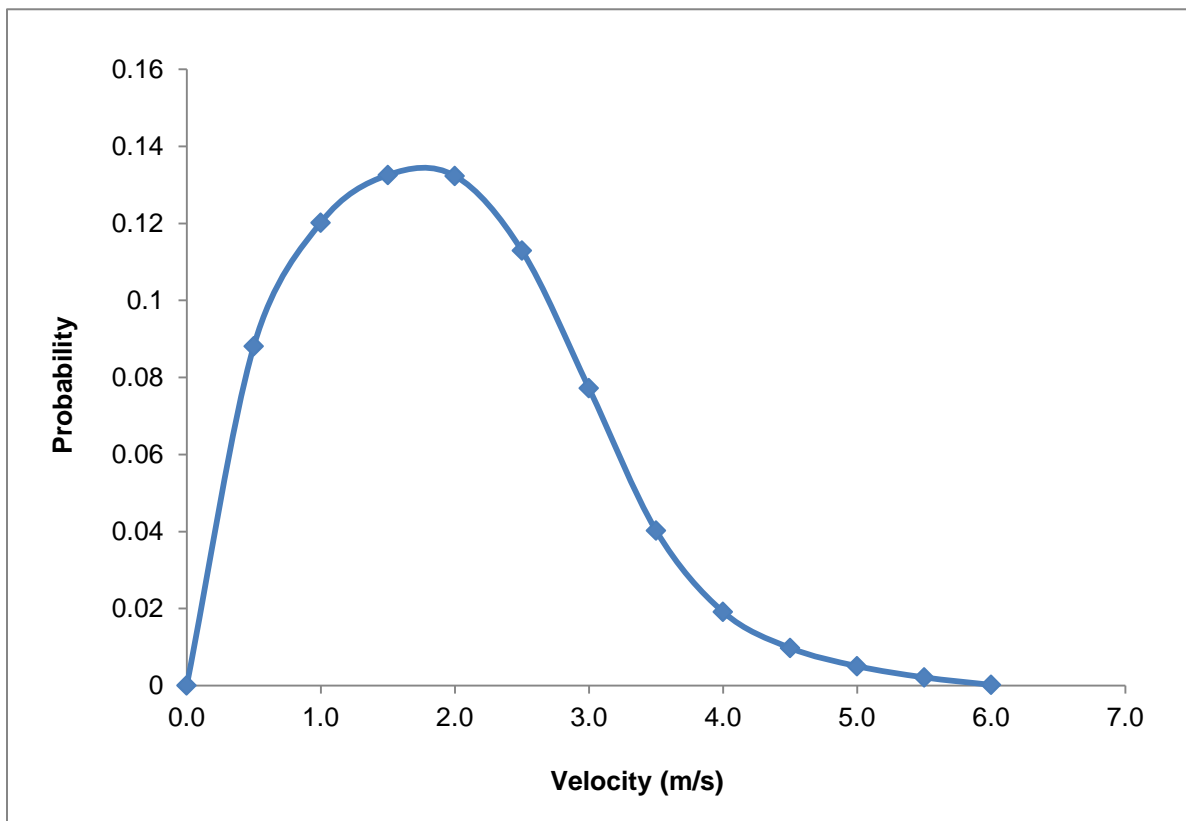
Figure 7. Probability distribution of velocity at blade tip. At low tidal velocity (26% of the time), the blade is stationary (not shown here).

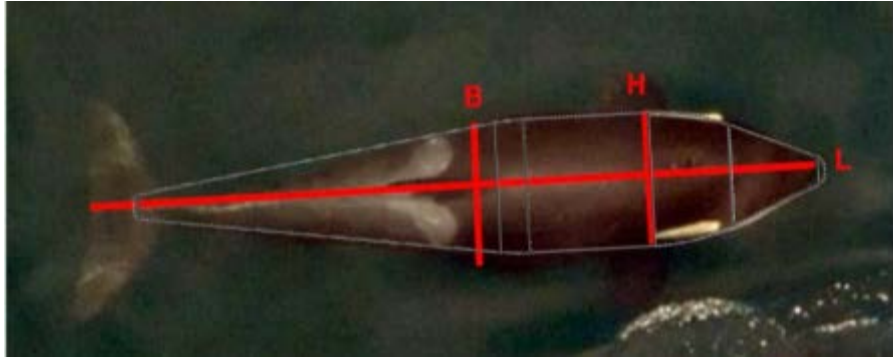
Figure 8. Basic dimensions measured for SRKW (Durban et al. 2009).

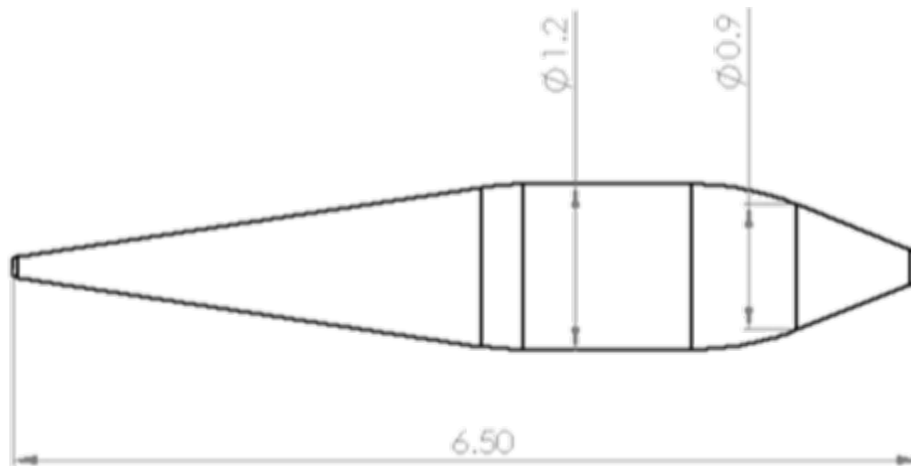
Figure 9. Maximum dimensions reported for an adult male SRKW.

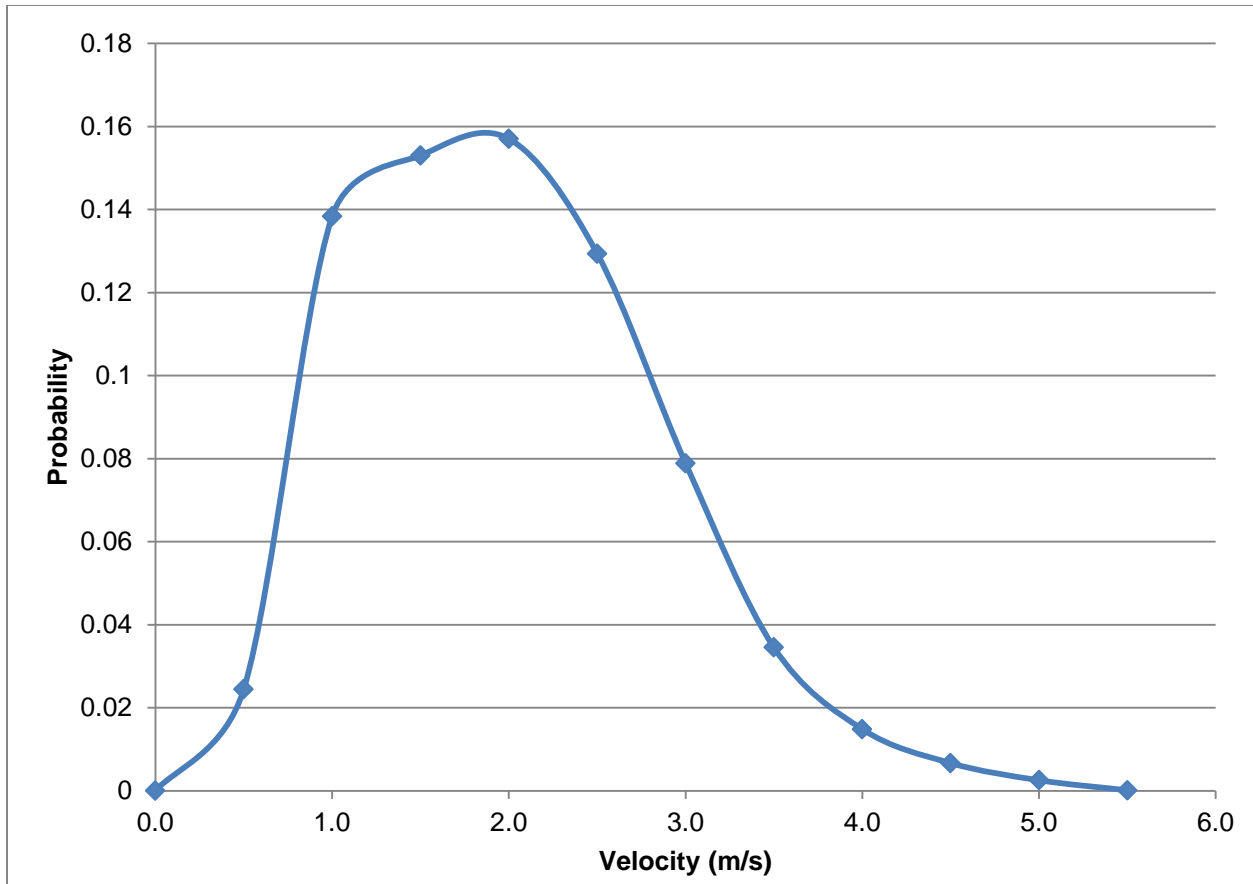
Figure 10. Plot of probability distribution for velocity at a location of 0.4 m from the tip of the blade.

It will be difficult, if not impossible, for an adult SRKW to impact the blade at the radius farthest from the center of rotation due to the cowling around the turbine, and there is a similar restriction due to a cowling around the open area in the center of the rotor. Therefore, the blade velocity was applied to the location where the head of the whale could be inserted farthest into the turbine rotor, still an unlikely scenario but one that would have the most adverse effect on the whale. This causes the most absorption by the tissue due to impact and is the most conservative impact location scenario (Figure 5 [left] and Figure 9). The most severe impact with respect to tissue damage (i.e., skin and subcutaneous injury) would be for a large mass (i.e., adult male) to be hit as close to its center of mass as possible. This forces the tissue to absorb more of the impact rather than simply moving the mass (the whale) out of the way. The maximum penetration of the nose of the large adult SRKW would extend approximately 0.4 m from the tip of the nose, at a 2.0-m radius on the rotor. The probability distribution as a function of blade velocity is demonstrated in Figure 10. The probability distribution has a shape similar to the blade tip velocity (Figure 7), but has higher probabilities at lower velocities and the terminal velocity is lower because the radial distance for the modeled location of contact is closer to the center of rotation. The engineering analysis was performed at 1, 2, 3, 4, and 5 m/s, informed by the velocity distribution seen in Figure 10.

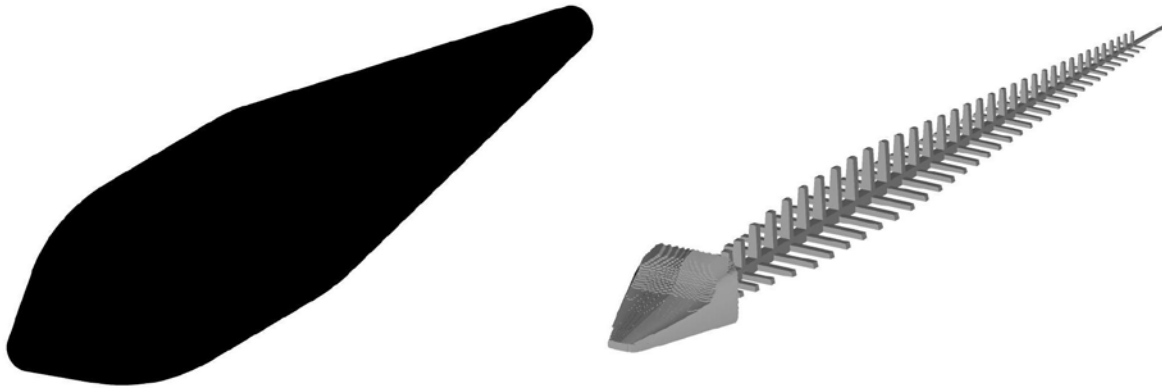
Figure 13. Skin and bone models (full geometry).

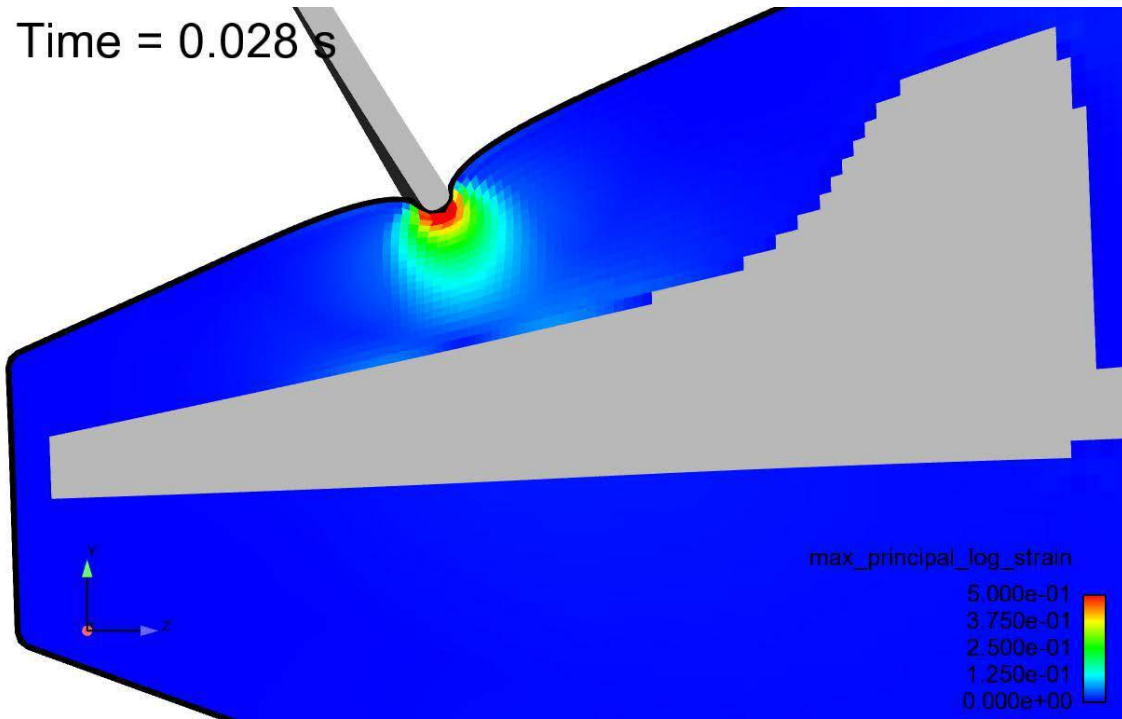
Figure 14. Blubber strain, 3 m/s.

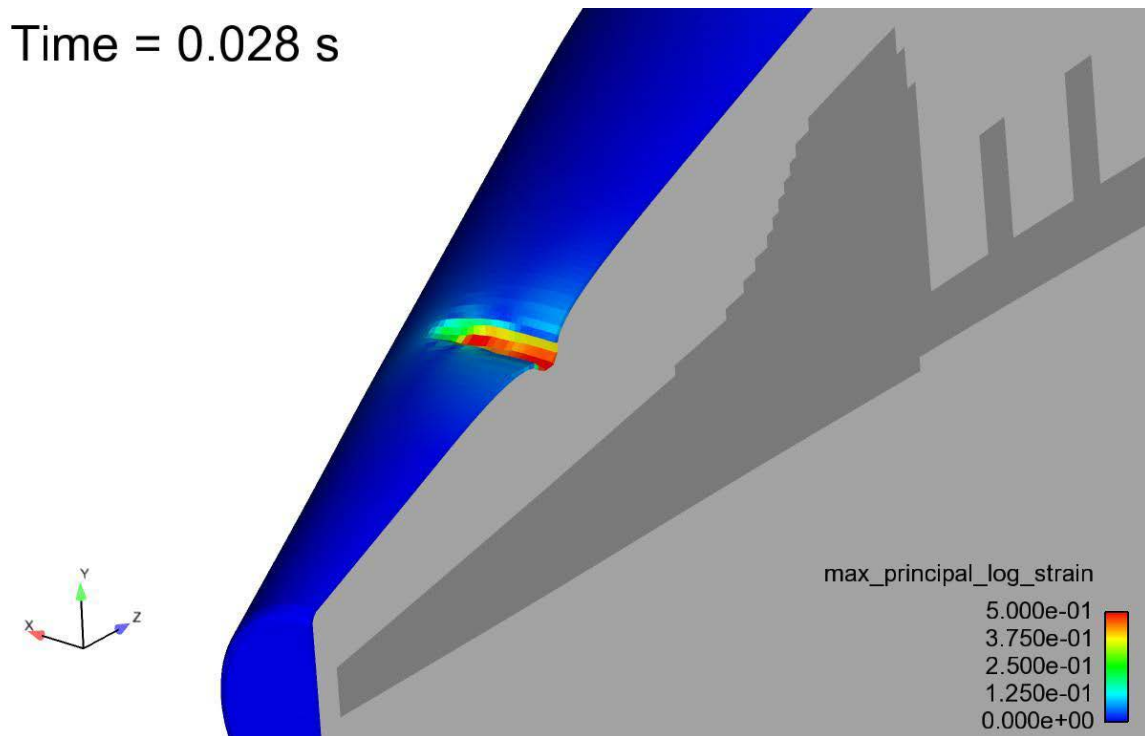
Figure 15. Skin strain, 3 m/s.

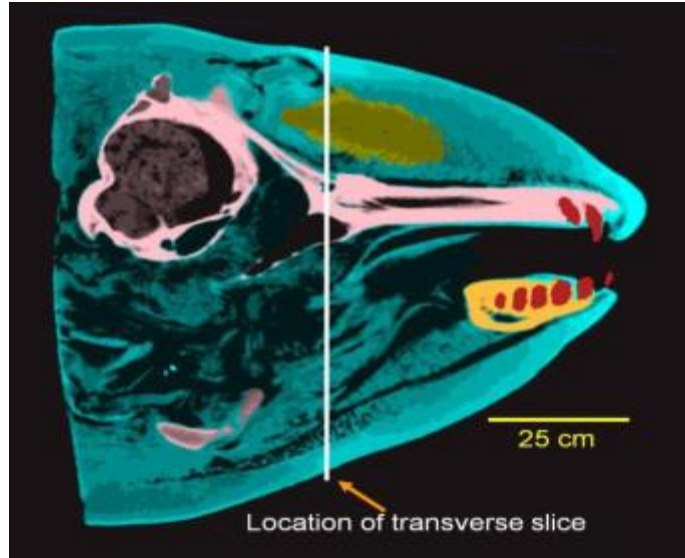
Figure A. 1. A sagittal CT scan of the head of an adult killer whale. Bone is shown as pink with the lower mandible in orange, teeth as red, voids are black, and other tissues in various other colors. Portions of the upper mandible of the whale’s jaw and a cross section through the whale’s skull are clear.

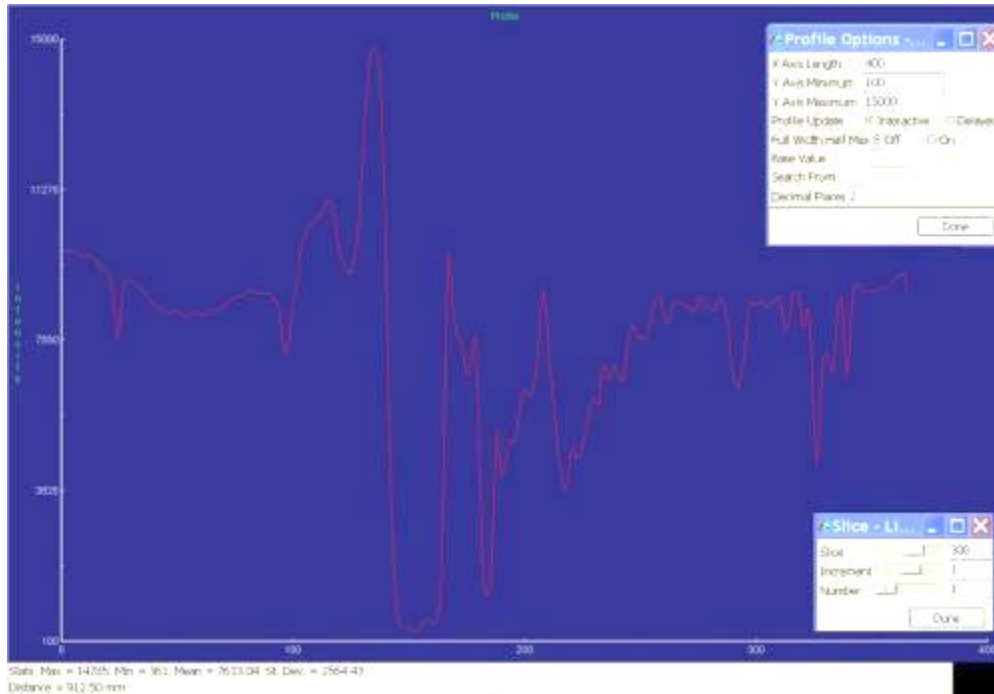
Figure A. 3 Intensity values along a vertical transect through a transverse slice of CT scan data for the head of a killer whale

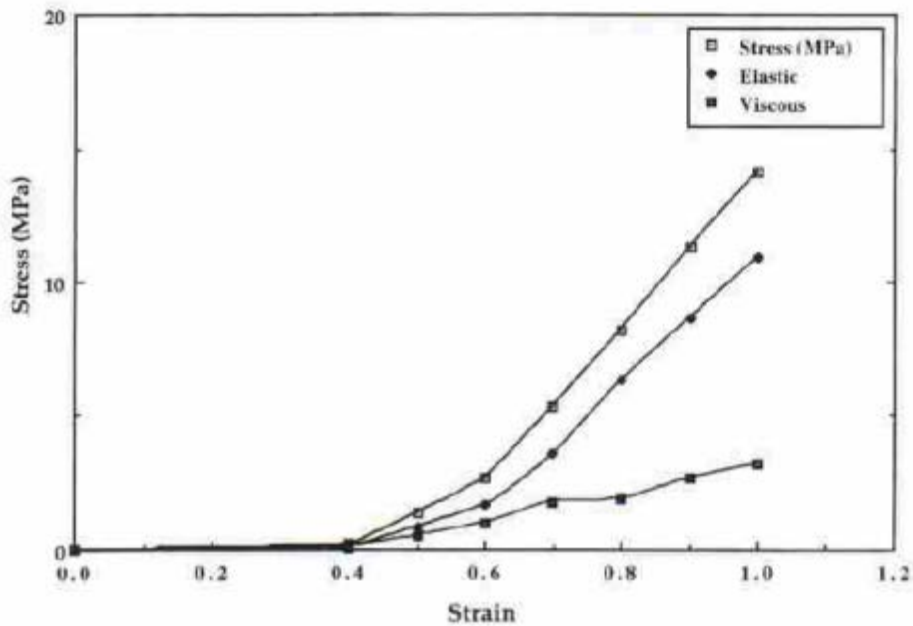
Figure B. 3. Relationship between stress and strain for human skin showing true stress (unfilled squares), elastic (diamond symbols), and viscous (filled squares) components (after Silver et al. 2001, Figure 2)

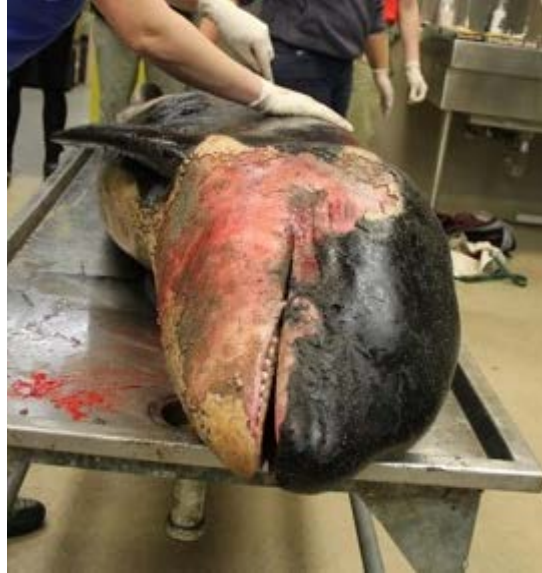
Figure C. 2. Necropsy of SRKW neonate carcass. The skin sample was the entire head region above the jaw including the blowhole. Note: the neonate's skin was debrided (likely due to surf and sand) on the right side of the animal's head, jaw, and throat area. (Photo by: Kim Parsons, NOAA Fisheries)

A second skin sample was obtained from a newborn (neonatal) male SRKW from the SRKW J-pod that died in January of 2013. The sample consisted of a continuous piece of skin that began just above the upper jaw and continued over the top of the neonate's head, and included the blowhole (Figure C. 2). The neonate tissue sample was frozen for three weeks before testing.

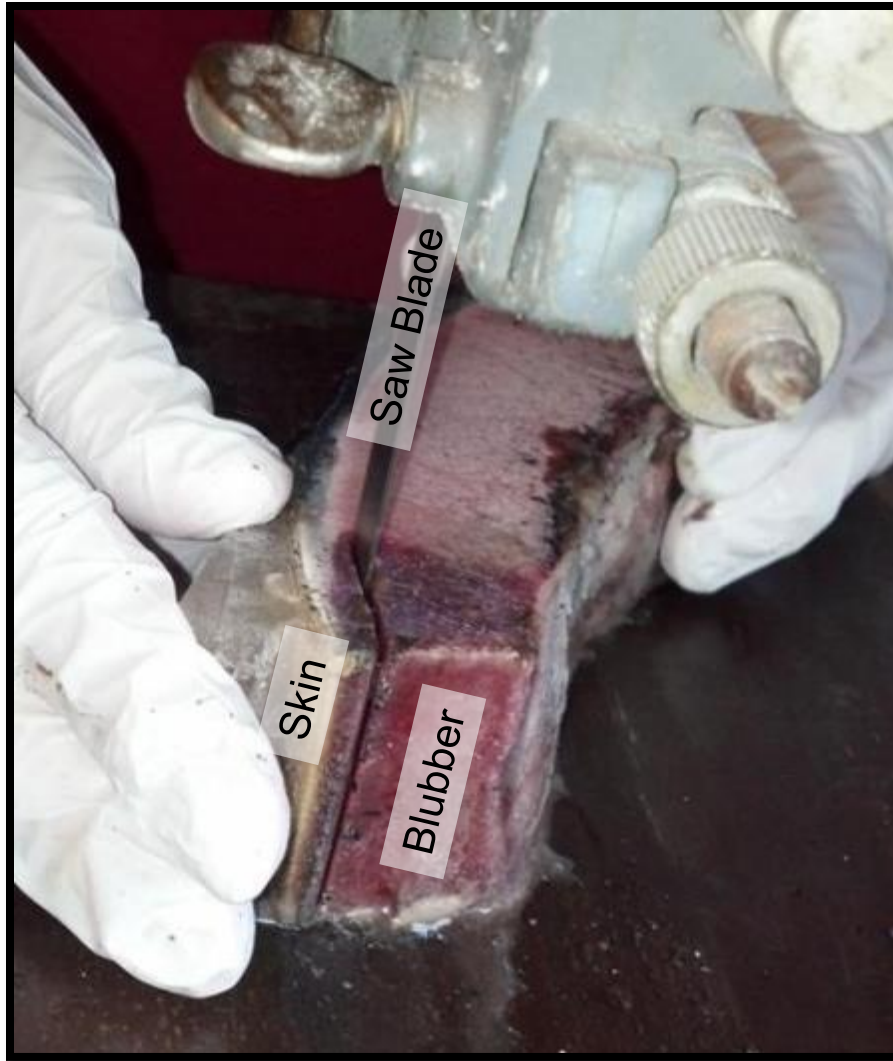
Figure C. 4. The photo shows the second stage of processing of a frozen subsample of juvenile skin tissue where the blubber and epidermal layers are separated using a band saw. The blubber remained frozen through this process and was returned to the freezer for later use immediately after being separated from the epidermis.

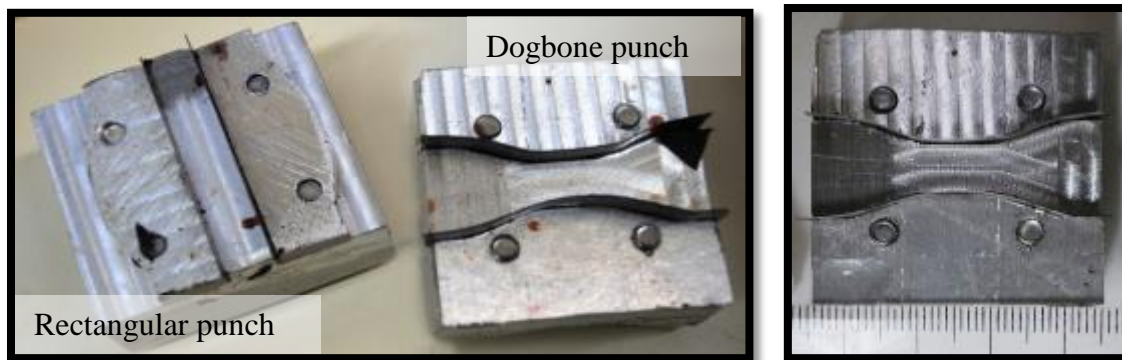
Figure C. 6. Dogbone and rectangular tissue punches are shown above. Samples prepared with the rectangular punch were 40 mm long and 7 mm wide. Those prepared with the dogbone punch were 40 mm long and were 15 mm wide at the top and bottom and 7 mm wide in the narrower middle section.

Two different die-cut punches, dogbone and rectangular, were manufactured in the laboratory and used to prepare tissue samples for testing (Figure C. 6). The punches were made of aluminum and hold microtome (razor) blades to cut the tissues. The two punches were used to test different properties of the material. A dogbone punch is more appropriate for a maximum strength of the material, as the shape concentrates the stress in the smallest cross section of the sample and therefore breaks more consistently. The rectangular shape was more appropriate for understand the elastic modulus of the tissue.

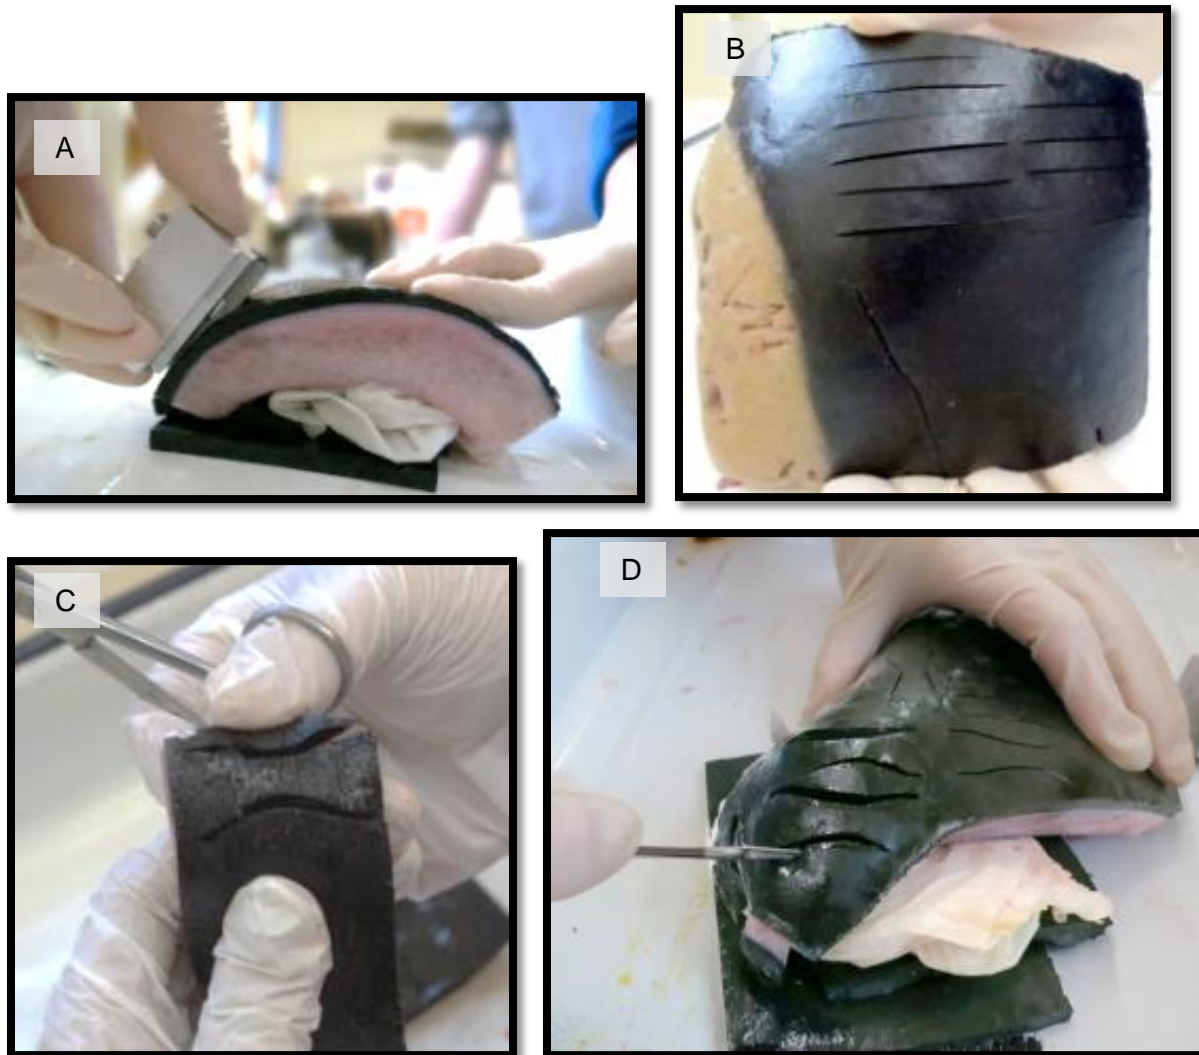
Figure C. 7. Rectangular and dogbone test-sample extraction from blocks of epidermal tissue. Panel A shows the rectangular punch being used to make the initial cut into the tissue block. Panel B shows the results of the punch use shown in panel A. Panel C and D shown the results of use of the dogbone punch on blocks of epidermal tissue and the use of a scalpel to complete removal of test-samples from the block of epidermal tissue.

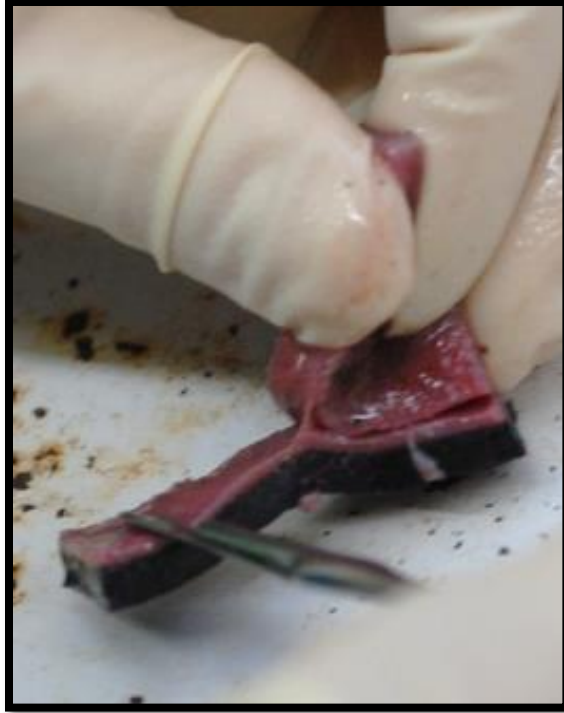
Figure C. 8. The final step in epidermal test-sample preparation was removal of blubber. Because the blubber layer is firmly attached to the skin layer it had to be cut away using a scalpel.

Test-samples were extracted from tissue block by first punching the outline of the sample in the tissue then extracting the test-sample from the tissue block using a scissors and scalpel (Figure C. 7). In the case of epidermal samples, the thickness of the block of tissue was always thicker than the punch blades were long, even when much of the blubber layer was removed with the band saw or meat slicer during preparation of the block of sample tissue. The remaining thickness of blubber was cut away from the sample of epidermis by hand to extract the final test-sample (Figure C. 8).

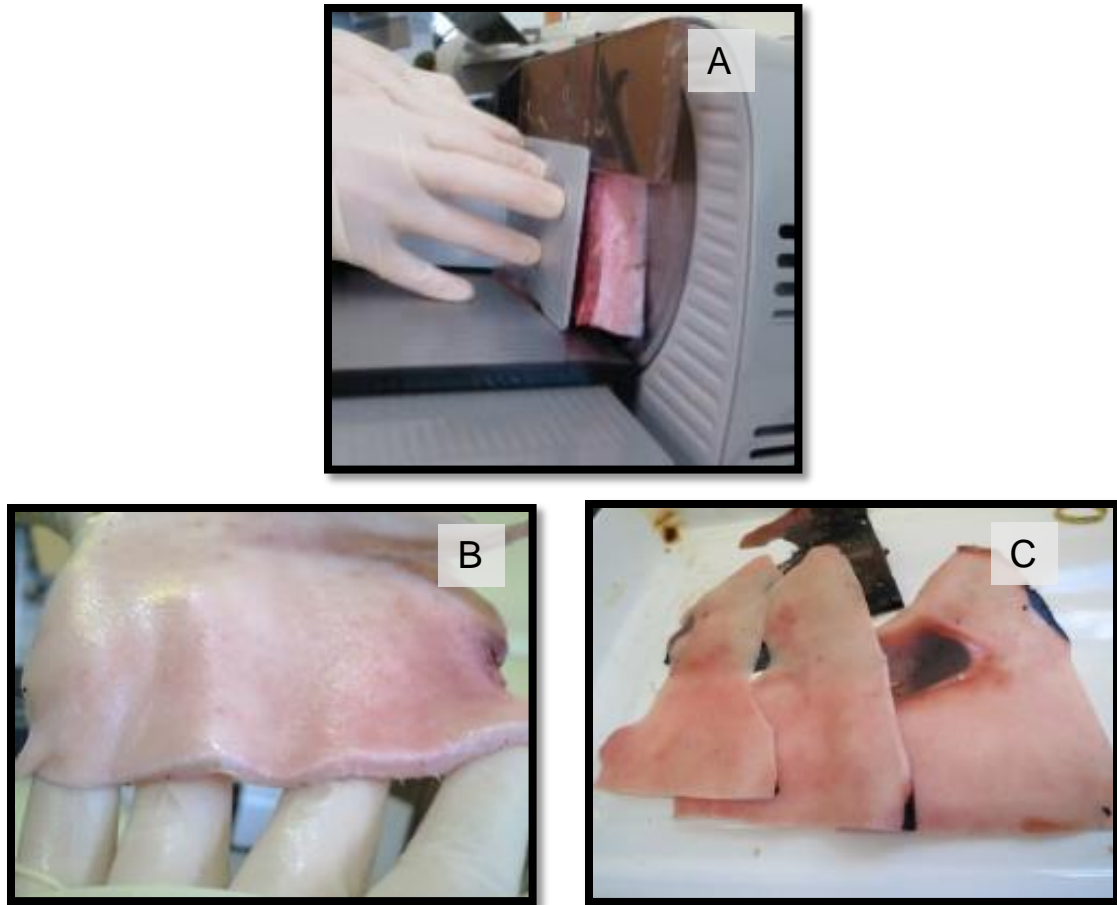
Figure C. 9. Panel A shows a section of blubber being prepared for sectioning using a meat slicer. Panels B and C show the resulting slices of blubber. As many as three slices of blubber 3-5 mm thick could be obtained from a block of blubber tissue..

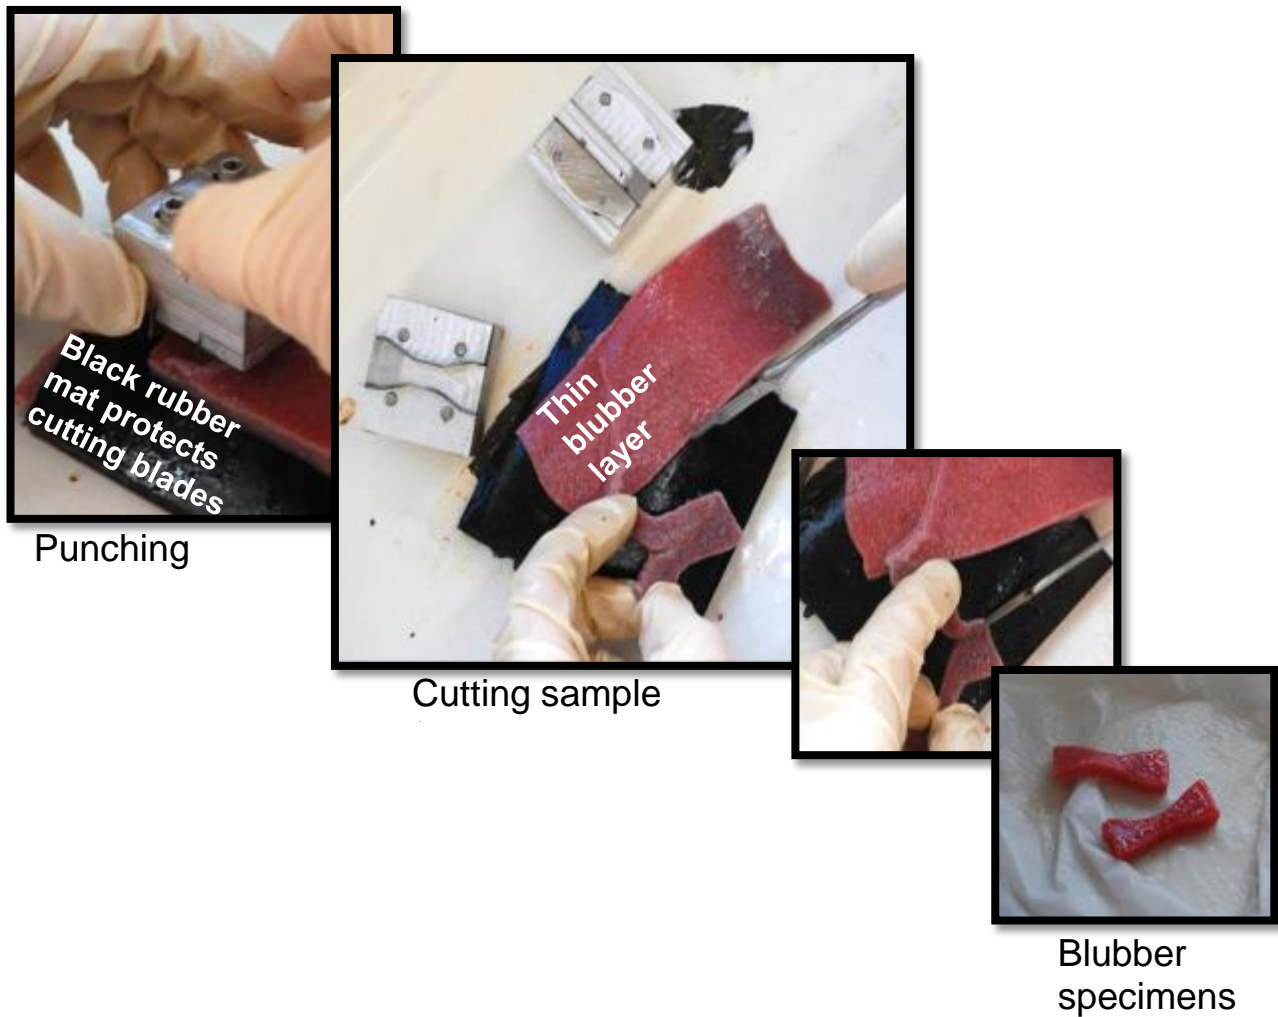
Figure C. 10. The steps in preparation of dogbone samples for tension testing from a slice of blubber are shown. The first panel shows the use of the dogbone punch on the blubber slice. The second and third panels show steps in using a scapel to finishing cutting the test-samples from the slice. The fourth panel shows the completed dogbone blubber test-samples.

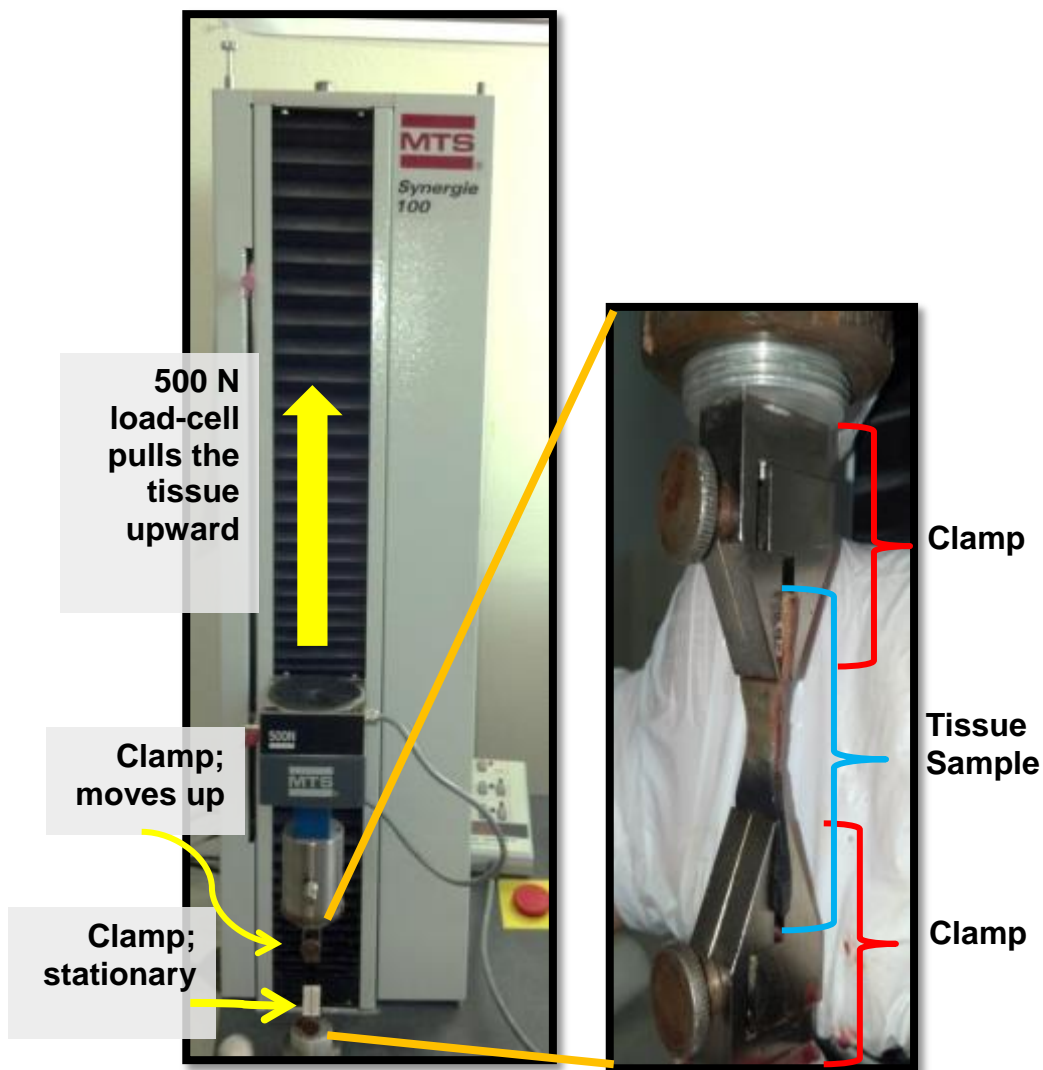
Figure C. 11. The MTS system shown with a test-sample held by the upper and lower clamps under slight tension immediately prior to testing. The left panel shows the MTS with the clamps in their starting positions. The right panel is a close up of a sample of epidermal tissue held at tension between the MTS clamps prior to testing.

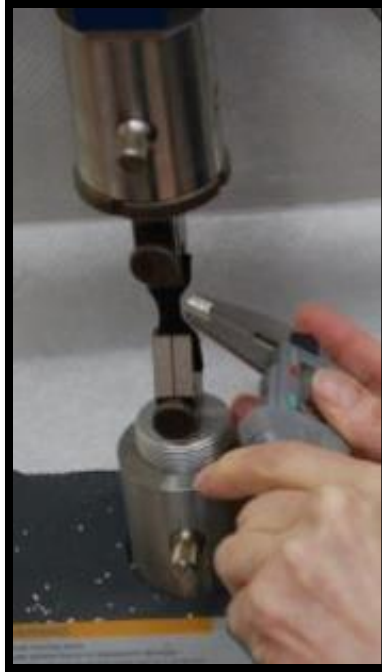
Figure C. 12 Following loading of the test specimen its thickness was measured to the nearest 0.001 mm as shown above using a digital caliper.. The sample thickness was entered into the MTS software program at the beginning of a test.

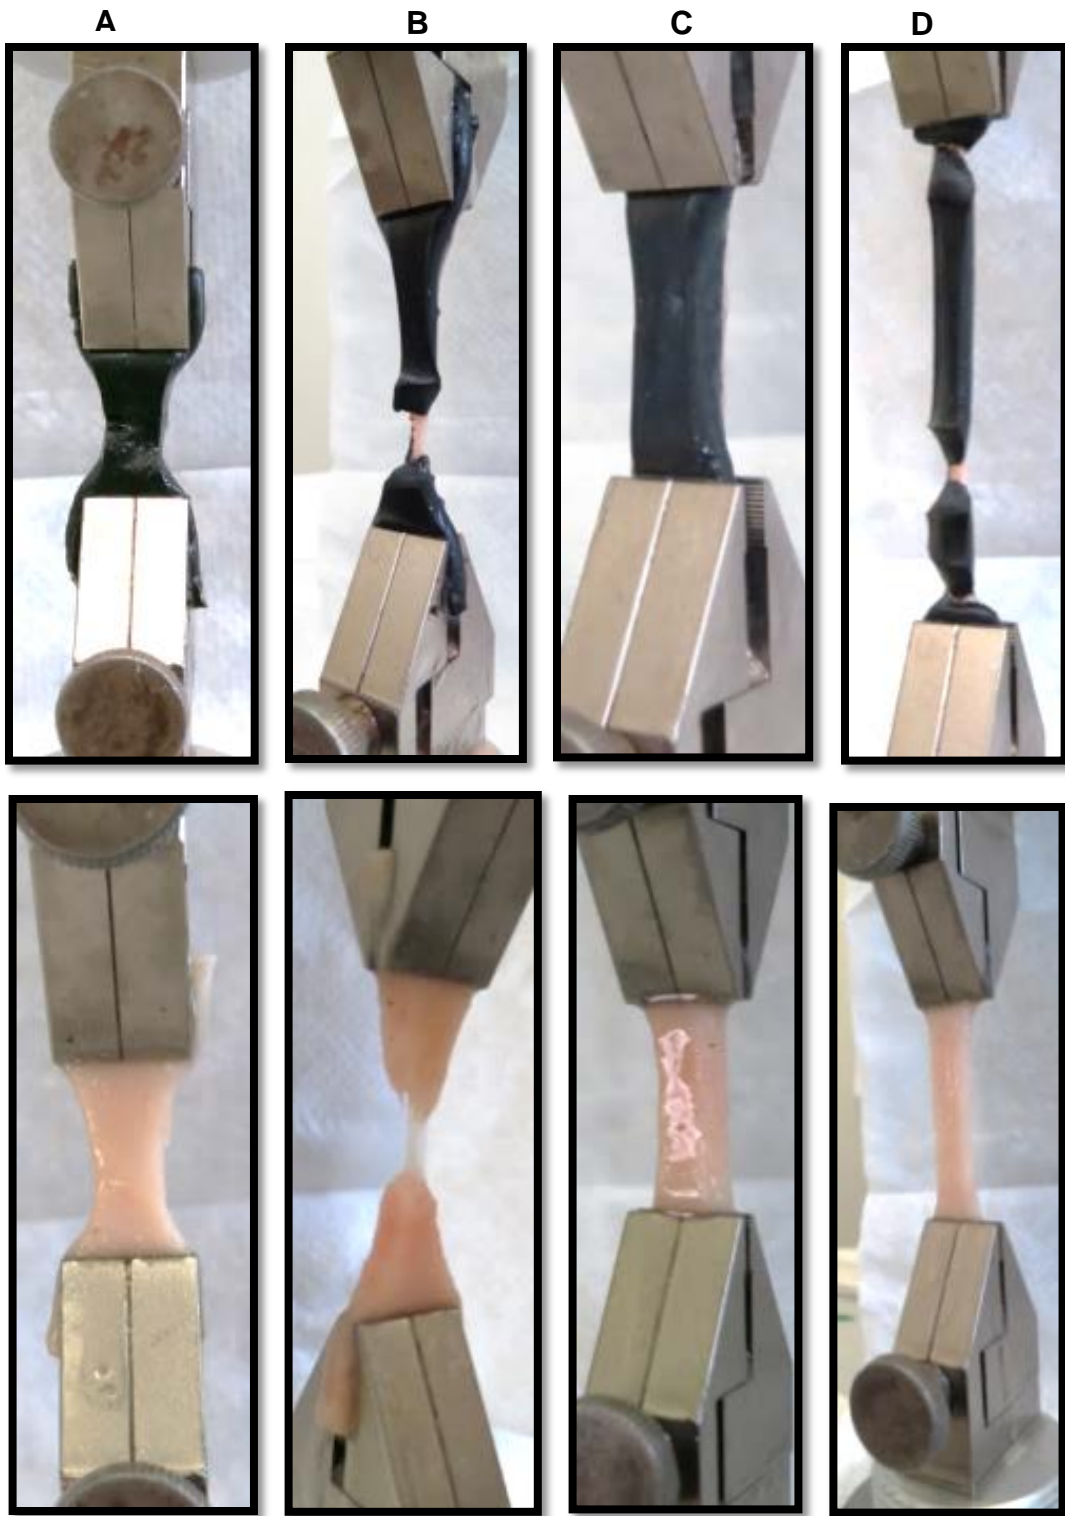
Figure C. 13. The panels in this figure show dogbone and rectangular test-samples of epidermal and blubber skin tissue at the initiation and conclusion of test. In the top row panels A and B are for a dogbone sample of epidermal tissue and C and D for a rectangular sample of epidermal tissue. The bottom row of panels show dogbone and rectangular samples of blubber (hypodermal) tissue at the initiation and conclusion of testing. At the initiation of testing samples are under a very slight stress and at conclusion exhibit signs of mechanical failure of the tissue such as rips, tears, or breaks.

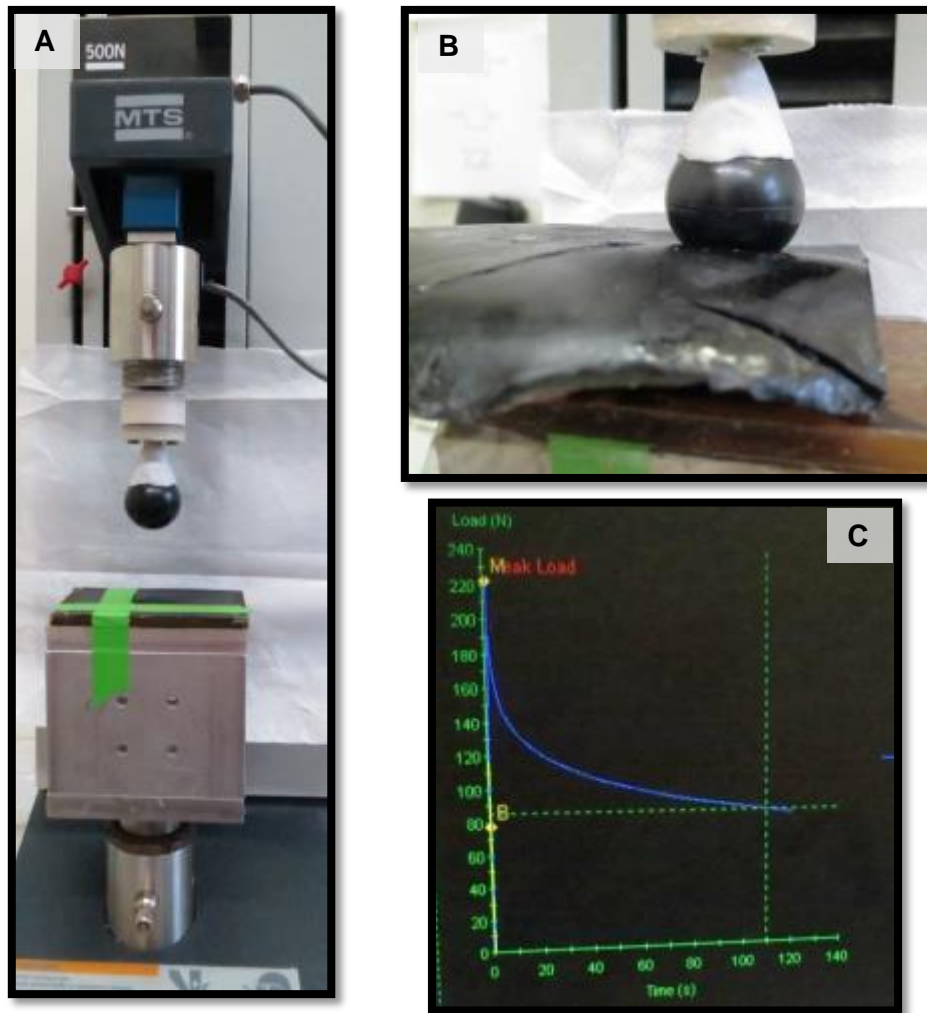
Figure C. 14. The MTS apparatus set up to conduct compression testing is shown in the first panel of the figure. The sphere used for the test and the platform on which the tissue samples were placed are shown. The top right panel shows a sample of skin tissue during compressive testing with the sphere indenting the surface of the tissue. The bottom right panel shows the output of the testing which is the force in N applied to the sample as a function of time in seconds.
