Assessment of Strike of Adult Killer Whales by an OpenHydro Tidal Turbine Blade

Final Report

January 2014

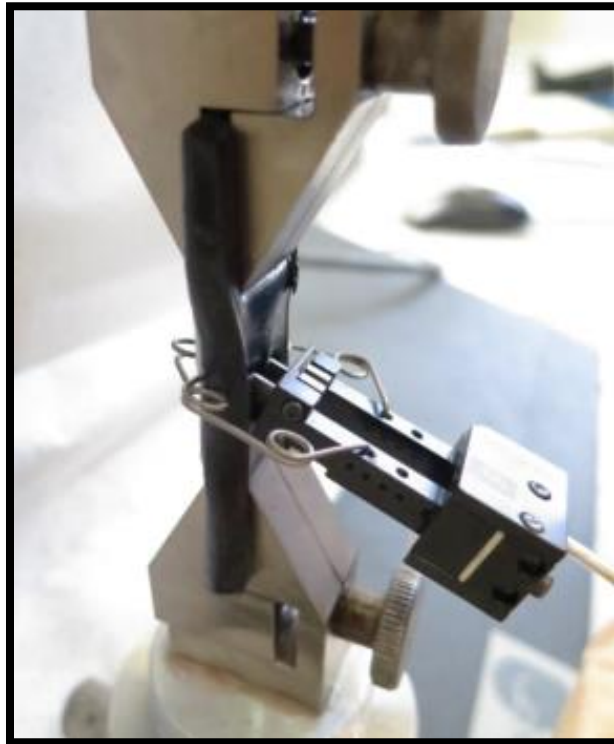
Figure C. 15. The figure shows the MTS with a sample of neonate epidermal tissue within its clamps and an extensometer attached to the sample to measure lateral strain through the test.

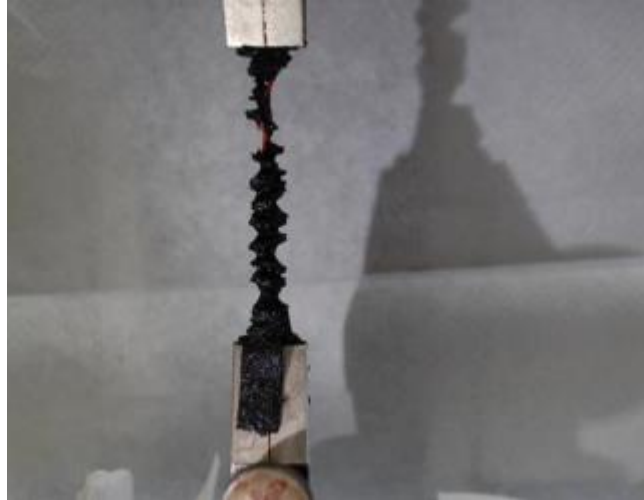
Figure C. 61. Juvenile Skin Rectangular specimen after testing. An example of a thin layer of skin sloughing off can be seen on the bottom clamp. This is a sign of the degradation of the juvenile skin tissue and often happened during tensile testing.

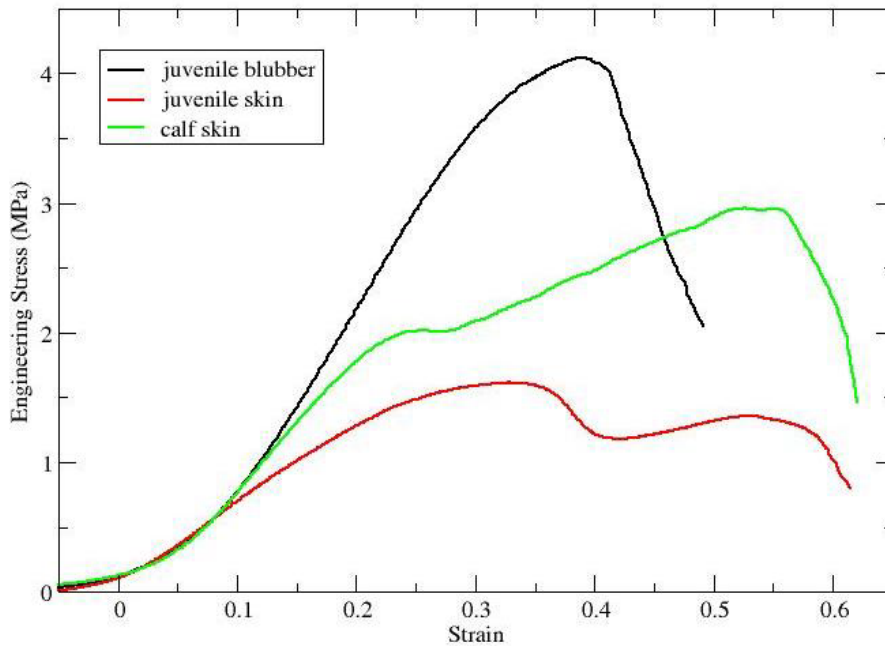
Figure D. 4. Anterior to Posterior (90°) Rectangular Sample Tissue Data. Each stress strain curve highlights a representative sample from that specified series of testing.

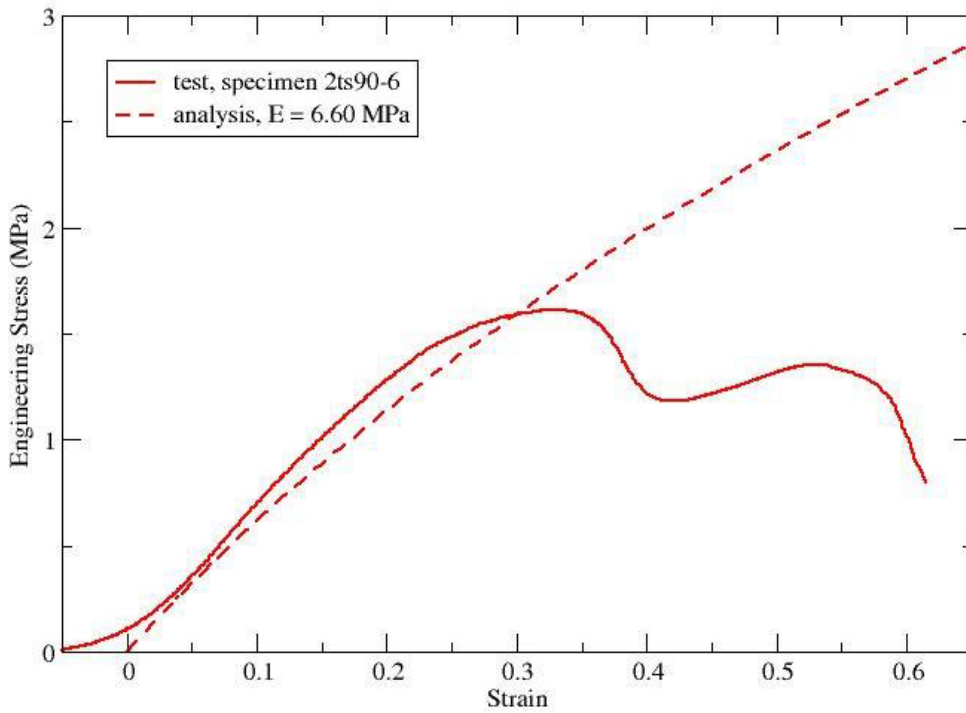
Figure D. 6. Dotted line represents the finite element analysis results for the juvenile skin tests with rectangular 90° specimens.

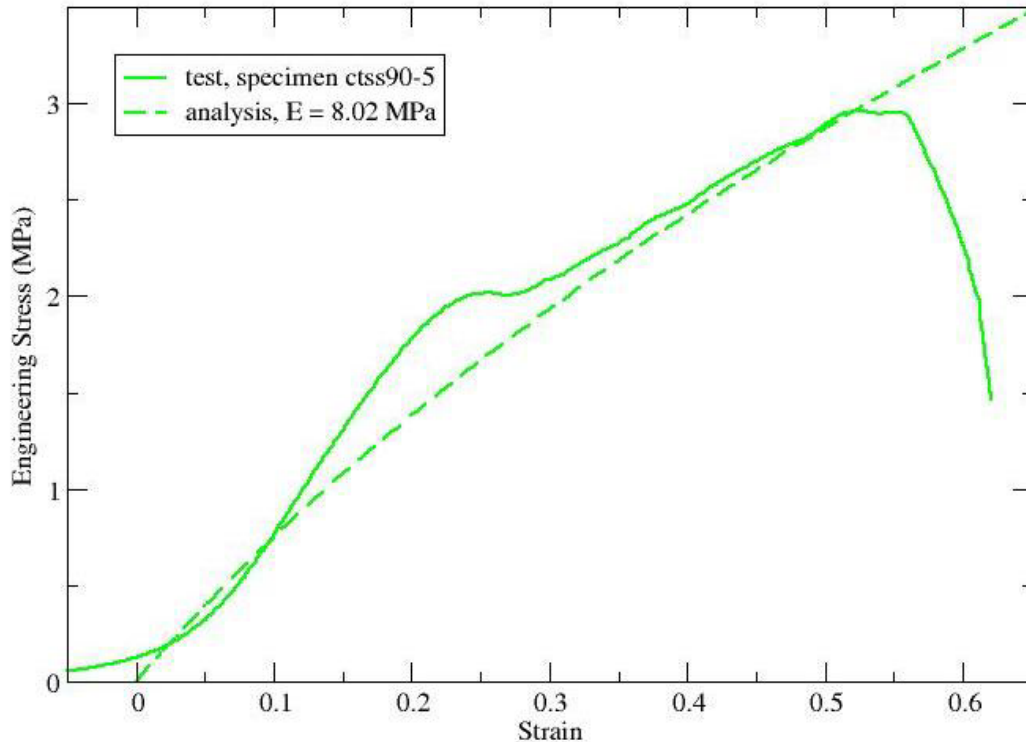
Figure D. 7. Dotted line represents the finite element analysis results for the neonatal skin tests with rectangular 90° specimens.

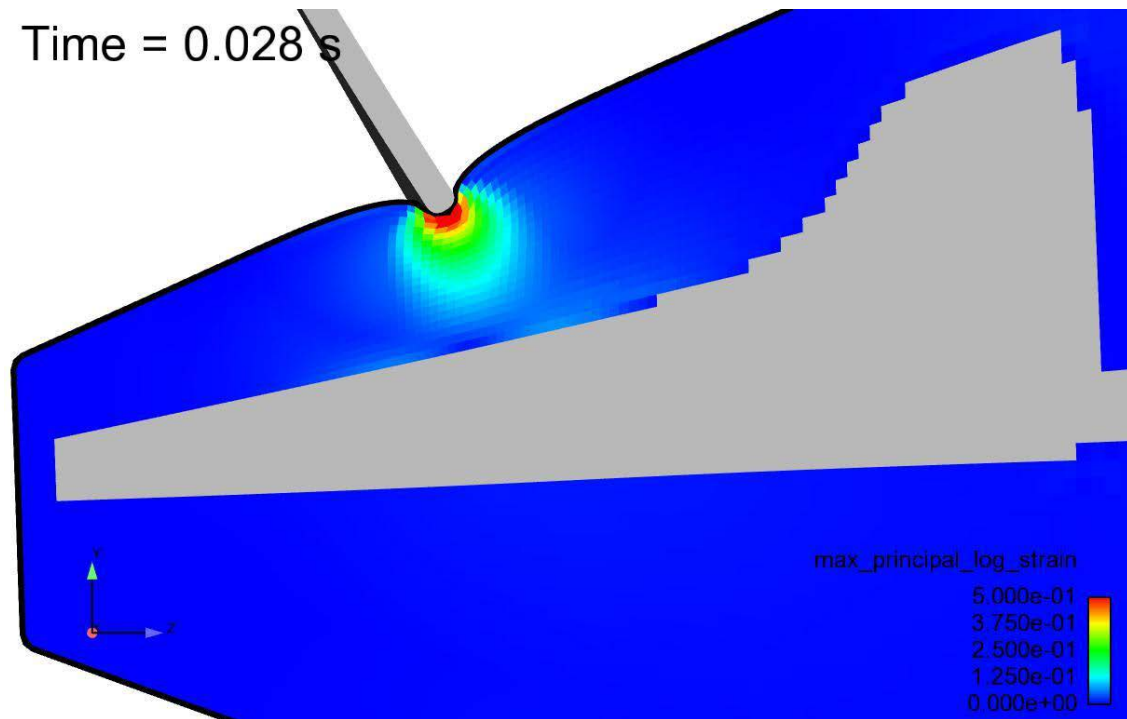
Figure D. 8. Blubber Strain, 3 m/s

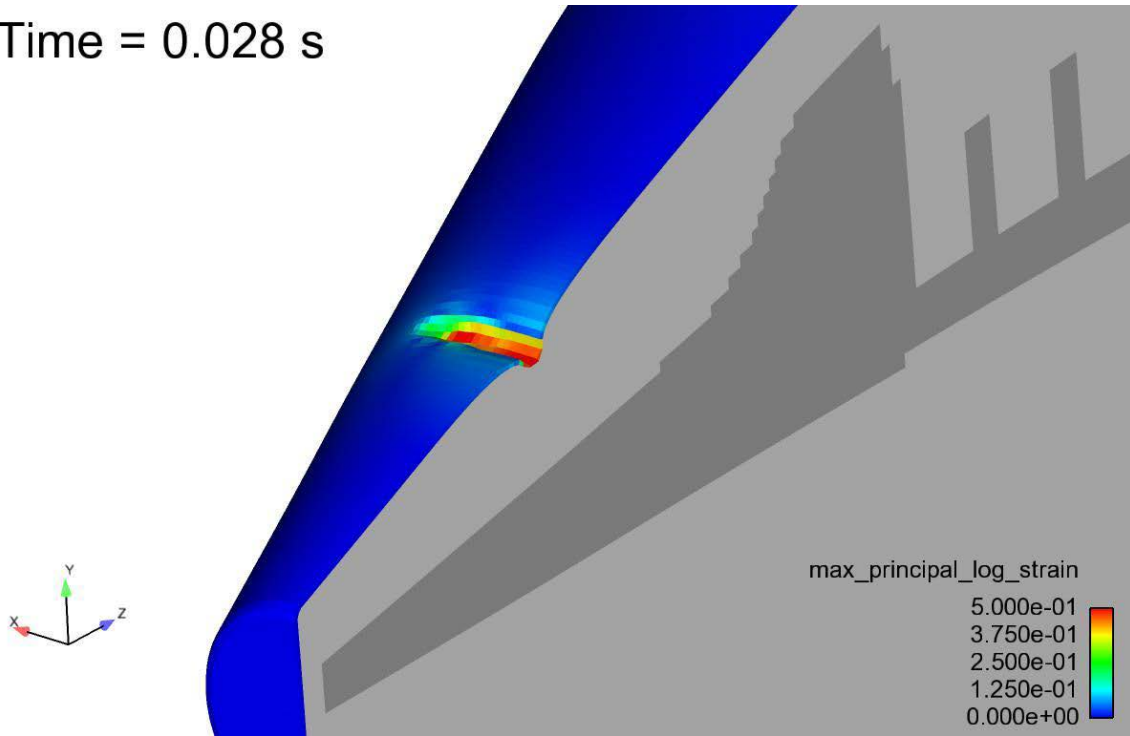
Figure D. 9. Skin Strain, 3 m/s
