Sound of Islay Demonstration Tidal Array

Inter-tidal survey of potential cable routes

Scottish Power Renewables

Final Report

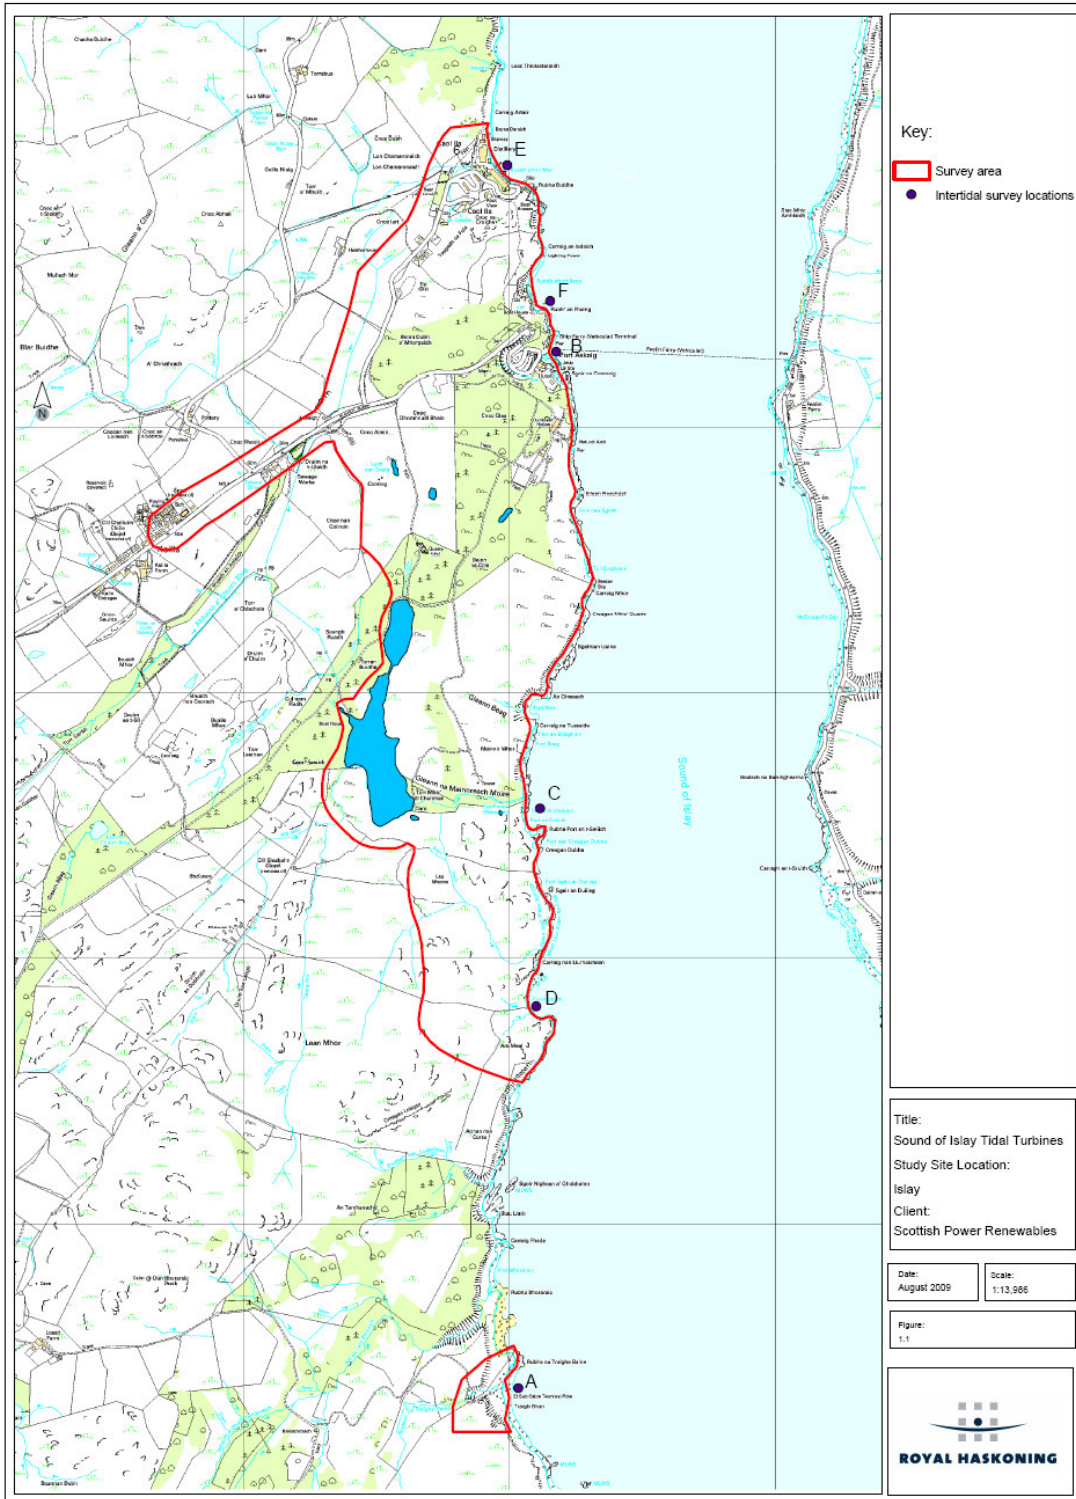
Figure 1.1 Locations of intertidal survey sites A – F.

To inform the Environmental Impact Assessment an intertidal survey was undertaken across an area shown in Figure 1.1. The intertidal survey was completed in conjunction with the Phase 1 habitat survey of potential cable routes.

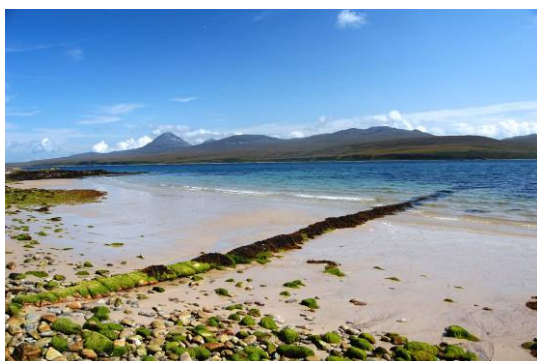
Plate 3.1 Transect A1 location along existing cable, viewed from the south west

Two transects were surveyed at this site (Figure 3.1) – the first (A1: NR 42951 65348, Plate 3.1) took the line of the existing cable to determine the species which had established on the artificial reef created by the cable armouring. Biotopes for this transect are described in Table 3.1 and Plates 3.3 and 3.4. The second transect (A2: NR 43047 65472, Plate 3.2) assessed the bedrock/rock pool outcrop to the north of the cable. Biotopes for this transect are described in Table 3.2 and Plates 3.5 to 3.8

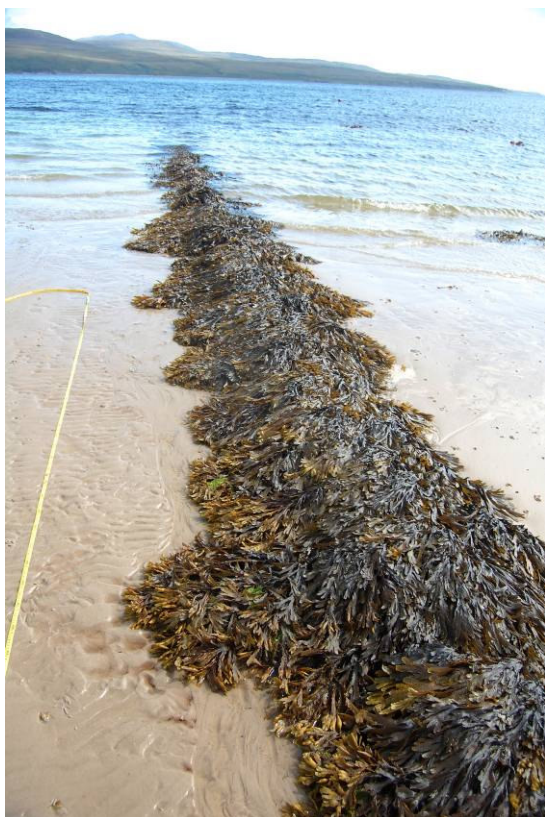
Plate 3.3 Transect A1 lower shore facing west, view along cable armoring

27.70 – 43.50	Cable armouring dominated by <i>Fucus serratus</i> supporting <i>Spirorbis spirorbis</i> , rare <i>Laminaria digitata</i> on scattered boulders. Cable armouring is on on clean fine sand sediments supporting <i>Arenicola marina</i> casts 5/m ² .	LR.LLR.F.Fserr.FS and LS.LSa.FiSa.Po
Below 43.50	<i>Laminaria digitata</i> , <i>Laminaria saccharina</i> and <i>Himanthalia elongata</i> on scattered half buried boulders, with <i>Fucus serratus</i> dominating the cable.	IR.MIR.KR.Ldig.Bo

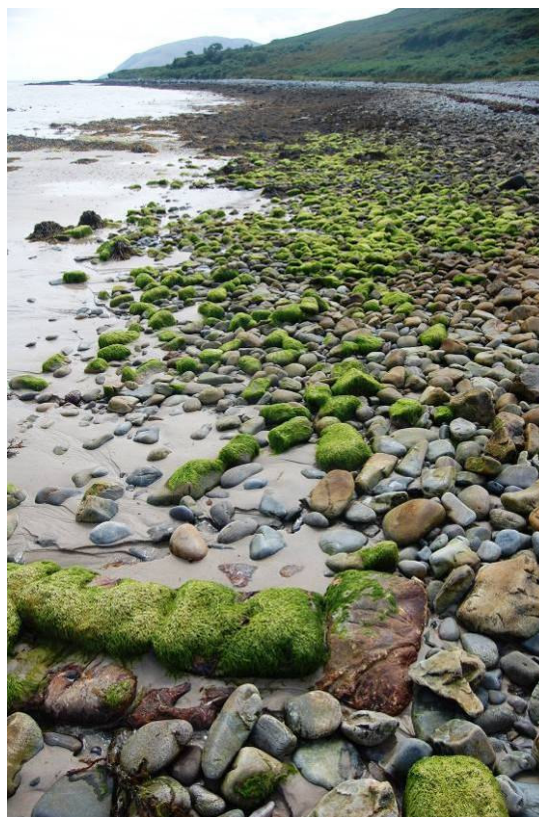
Plate 3.4 Transect A1 top of existing cable facing south

14.00 – 19.90	Cobble and pebble shingle, with <i>Ulva intestinalis</i>	LR.FLR.Eph.Ent
19.90	End of cable armouring, with <i>Ulva intestinalis</i> on cable end and on scattered cobbles. Clean fine sand sediments.	LR.FLR.Eph.Ent

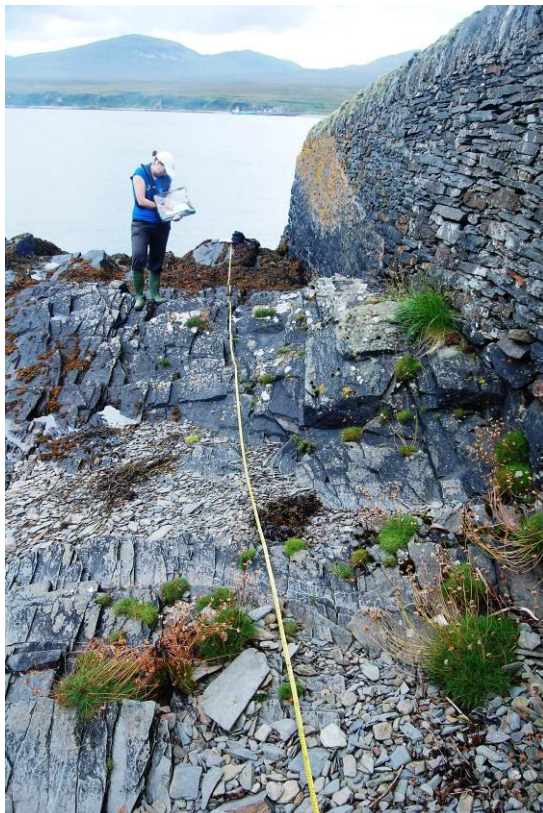
Plate 3.9 Transect B facing down the shore

The substrate was characterised by a complex matrix of bedrock encompassing natural steps, with a natural slipway through the bedrock of pebbles and shingles. Shingle and cobbles were present in the upper shore.

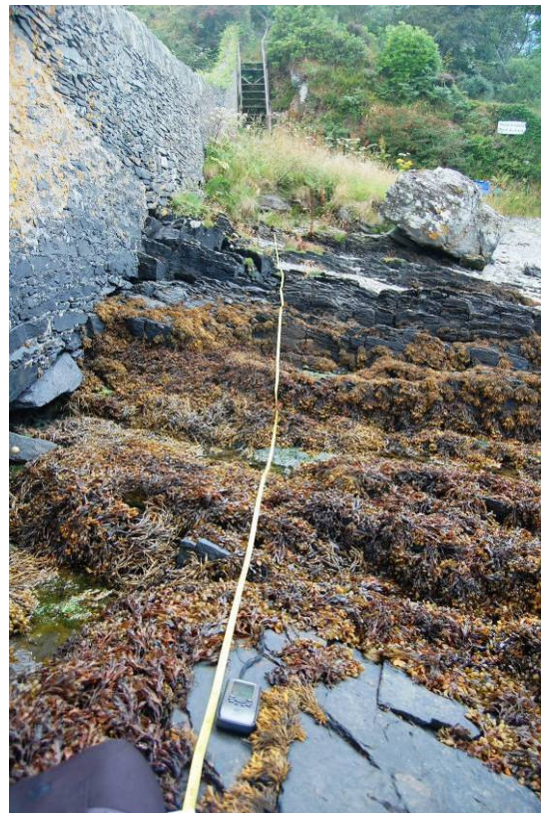
Plate 3.10 Transect B facing up the shore

Zonation occurred vertically up the wall, as well as horizontally up the shore. Zonation was similar on both sides of the wall, with no new species on the south side. Biotopes are described in Table 3.3 and Plates 3.9 – 3.12, while Figure 3.2 provides a map of the bay.

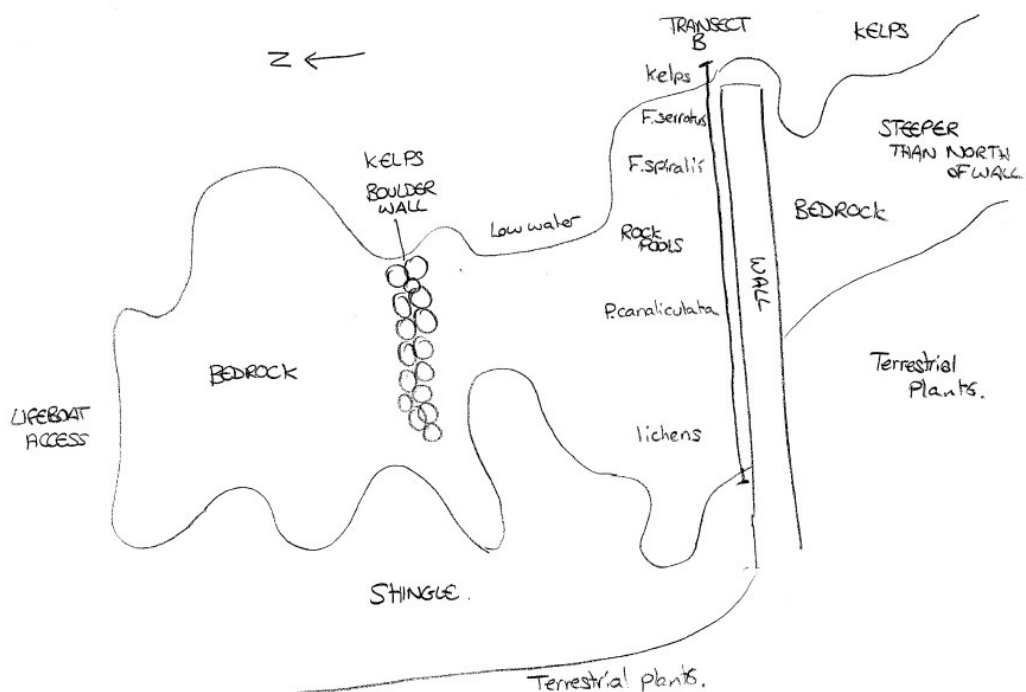
Figure 3.2 Map of Site B

Site B was surveyed on the 7th August 2009 at 1.50pm. The area to focus on as a potential cable route at Site B was identified by staff from the Islay Energy Trust just south of the lifeboat station, adjacent to the stone wall running down the intertidal zone from upper to lower shore, between land owned by the Port Askaig Hotel and the Dunlossit Estate. A transect was completed down the north side of the wall, with an assessment completed to the south and across the bay. No additional biotopes were recorded outside the transect.

From an environmental perspective, some of the potential landfall sites are preferable to others. Landfall Sites E (Caol Ila distillery) and B and F (Port Askaig respectively) are considered to be ideal as these areas are already developed with high anthropogenic influence relative to the other sites. In addition the surrounding terrestrial habitats for sites E, B and F do not contain the higher quality habitats or species richness found elsewhere in the footprint (Royal Haskoning, 2009). In addition, while landfall point A to the south of the footprint constituted a beautiful landscape with good quality intertidal habitat, there are already cables present at the site, as well as access and infrastructure. The presence of these attributes does not appear to have had a negative impact on the landscape or the quality of the habitat. Indeed, the cables seem to have created artificial reefs providing substrate for a diversity of sea weeds.

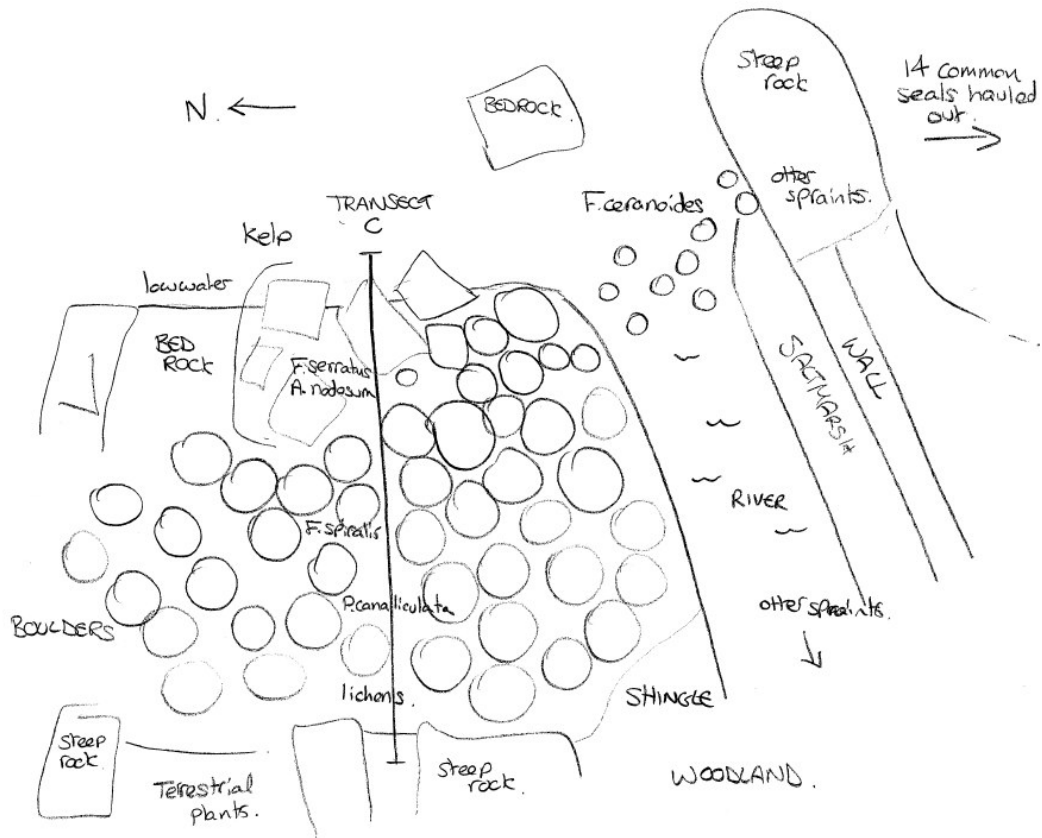
Figure 3.3 Map of Site C

Site C was a small embayment of cobbles, boulders and bedrock, accessed via tracks through the Dunlossit Estate, which lead to a small hydro-electric substation hut close to the shore. The site was surveyed on the 5th August 2009 at 12.30pm. To the south of the bay, a boundary wall continued from the terrestrial down shore to a small steep rocky headland. Inshore of the bay a deciduous woodland habitat is present, with a river running down the south side containing several large waterfalls. A small area of saltmarsh was present between the river and the wall, and the mouth of the river was dominated by *Fucus ceranoides*.

Potential landfall Sites C and D however, may be better avoided. Site C is at the site of a river mouth. This source of freshwater may be important for otters to maintain the waterproof properties of their fur. Indeed, several spraints were found on rocks in this river indicating that it is used by otters. Freshwater as easily accessible yet undisturbed as this river mouth may be scarce along the coastline, so if disturbance to the area can be avoided then that is to be recommended. This does not mean that works are totally precluded in this area, but a targeted otter survey would be recommended in advance of any construction.

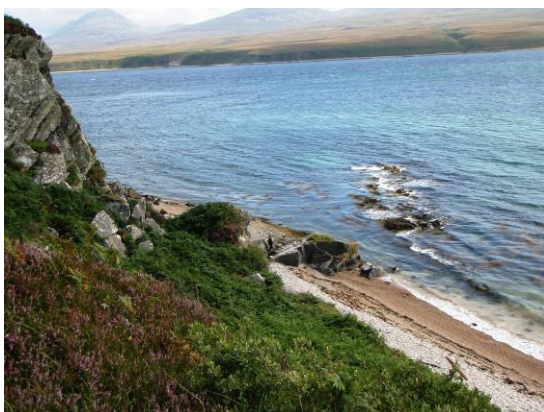
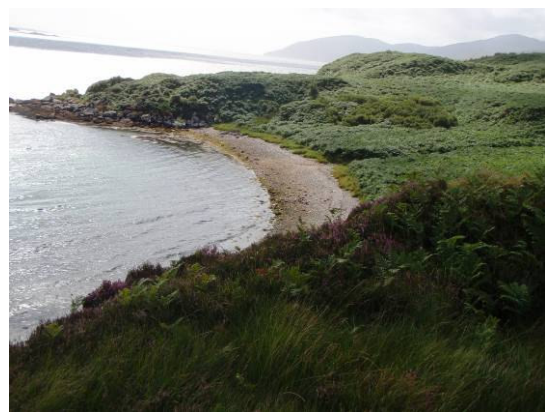
Site D was a wide west facing bay and predominantly consisted of a gentle gradient pebble-cobble beach leading down the shore into the subtidal zone. The site was surveyed on 5th August at 11.30am. Viewing this bay from the cliff top at low tide, it was apparent no species were present in the intertidal where cables were likely to be brought ashore due to the mobile nature of the beach substrate, and so a transect was not

completed at this bay (Plates 3.17 and 3.18). From the vantage point, dense *Himantalia elongata* was observed in the subtidal waters.

Plate 3.17 North end of Site D

Plate 3.18 South end of Site D

At potential landfall Site D, the area comprises a remote stretch of coastline surrounded by high quality wet heath habitat (Royal Haskoning, 2009). There is no access to the area and the disturbance that would be required to bring machinery and plant into the area would be high. It is therefore recommended that this area should not be developed.

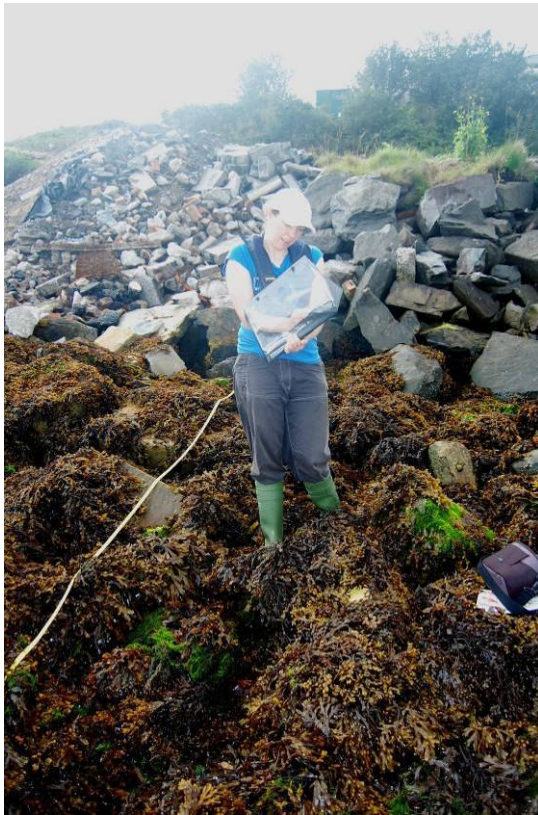
Plate 3.19 Site E transect up the shore

A transect was completed at the south of the bay (NR 43019 65471) close to the road where it was presumed best access for a cable route. The rest of the bay was walked over, with additional species recorded.

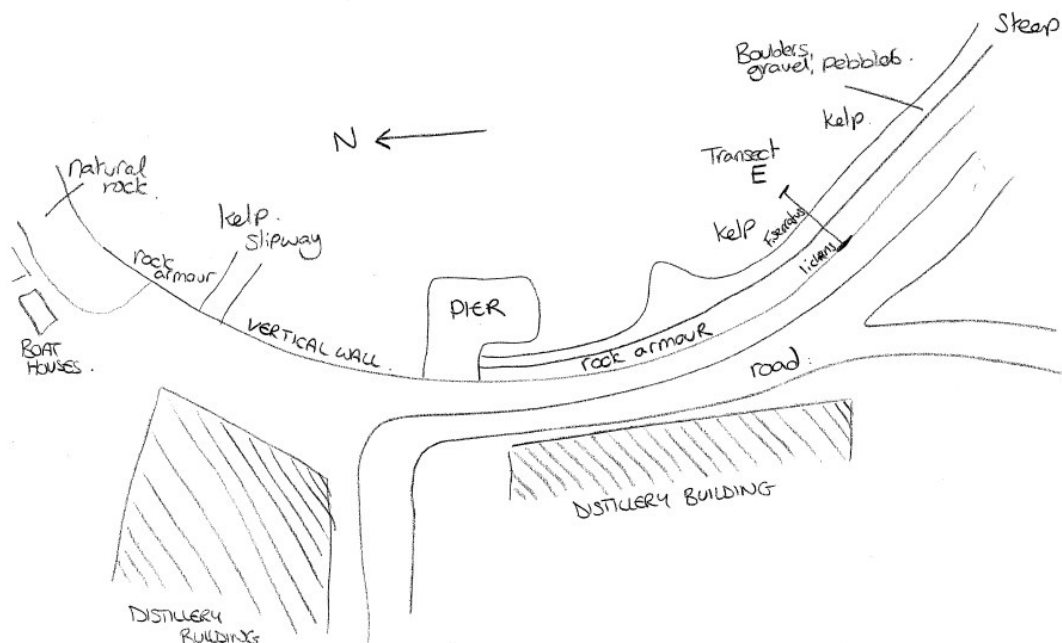
Figure 3.4 Map of Site E

Site E was a west facing sheltered bay and was surveyed on the 7th August 2009 at 11:30am. This site was industrialised compared to other potential cable route sites. The road to the distillery runs adjacent with the shore, with the intertidal substrate dominated by steep rock armour and vertical artificial seawall. A large pier was present in the middle of the bay.

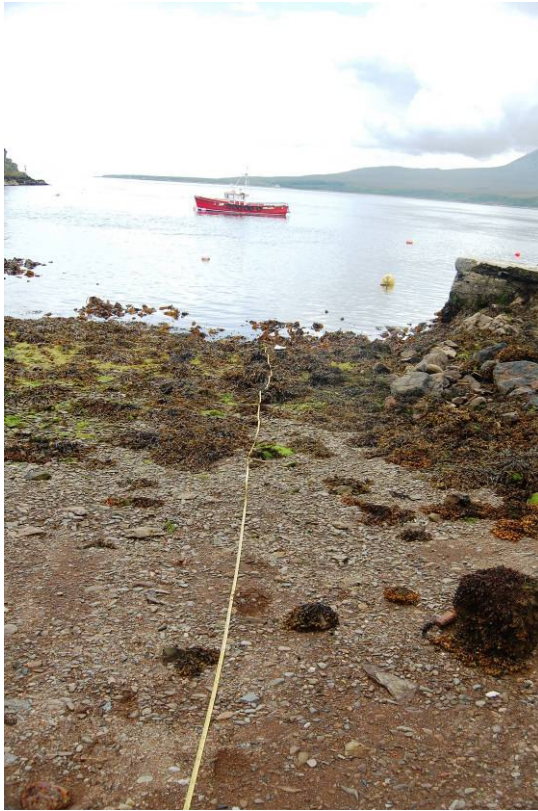
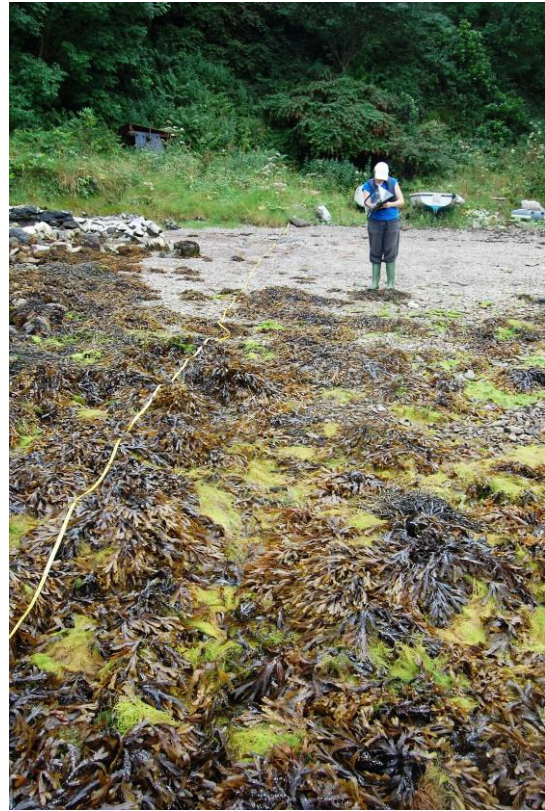
The transect (NR 43116 69433) was completed just north of a stone jetty where a pebble gravel substrate natural slipway was present leading up to a boathouse. Large boulders and bedrock existed across the rest of the shore. Several small boats were anchored in the embayment, and holiday cottages and a small boat house are present just above the shore. A small jetty was present in the rock in the south of the bay. North of the jetty the lichens *Ramalina siliquosa* and *Xanthoria parietina* were present above the high-tide mark with thrift (*Armeria maritima*). No other biotopes were observed on the site.

The non-native algae *Sargassum muticum* was identified within the transect at NR 43116 69433. This alga can cause displacement of native species and the sighting has been reported to SNH, who are currently monitoring the spread of *S. muticum* around the Scottish coastline.

Plate 3.24 Site F transect down the shore

Plate 3.25 Site F transect up the shore

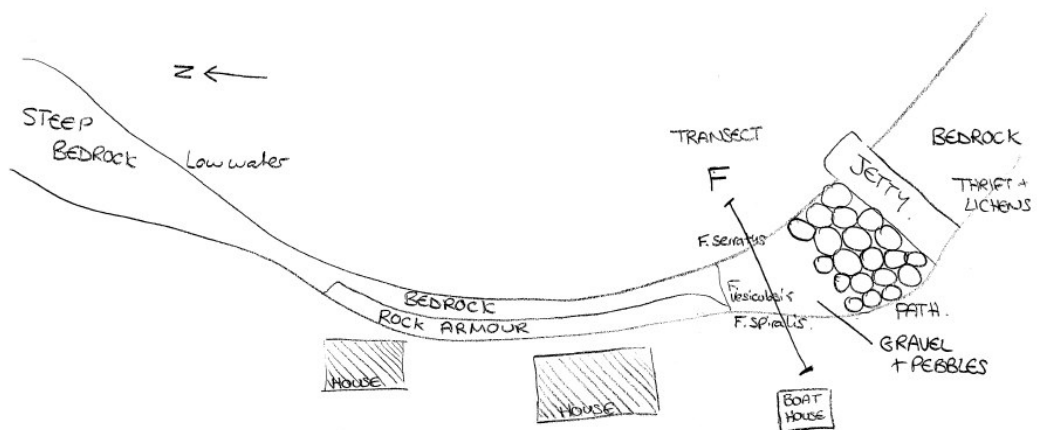
Figure 3.5 Map of Site F

The area to focus on as a potential cable route at Site F was identified by staff from the Islay Energy Trust as a small sheltered west facing bay set back from the cliffs, located between Port Askaig ferry terminal and Caol Ila Distillery. The survey was completed on 7th August 2009 at 12:50pm.
